**PHOTOGRAPHS OF THE STAFFORD BRANCH CANAL**  
**AT BASWICH (ST THOMAS') IN 1951**

**Introduction**

*Britain from Above* have twenty images on their Website of the former Baswich Salt Works. The images were taken on 14 August 1951 and uploaded in 2014.

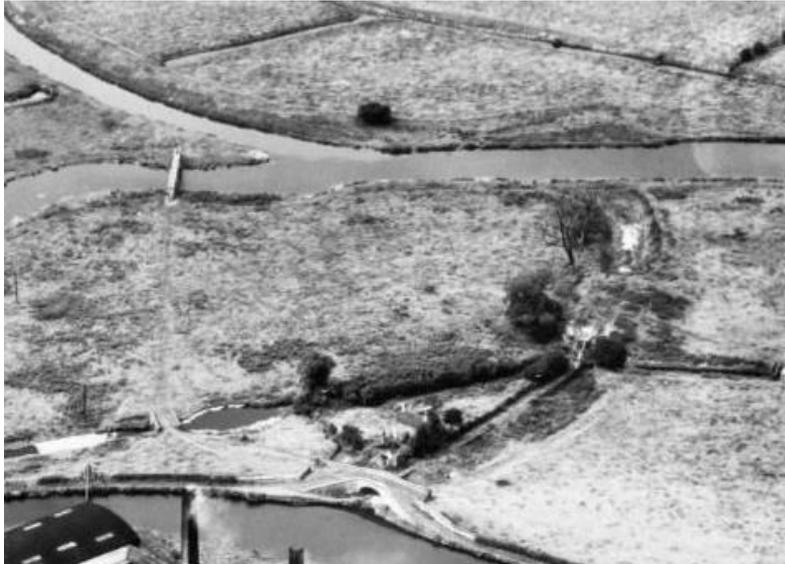
(a2) Another general view of the Site. At the top left is the River Sow. After about a mile the former Stafford Branch Canal / River Sow Navigation would terminate at the Coal Wharf just before Green Bridge in the centre of Stafford. (The photograph shows the Rivers Sow and Penk before they were realigned). [Ref: from EAW0653]

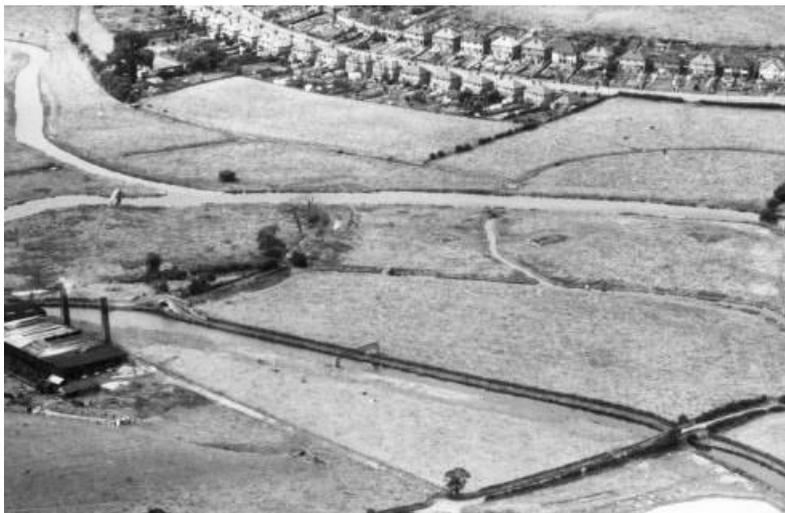
(a3) The Roving Bridge is visible opposite the Salt Works and there is a good view of the course of the former Branch Canal towards the junction of the Rivers Sow and Penk. The landscape east of the Lock House and Branch Canal is clearly shown. The houses on Tixall Road are at the top of the picture. Towards the lower right, St Thomas' Bridge (101) carries Baswich Lane over the Staffs & Worcs Canal. (The photograph shows the Rivers Sow and Penk before they were realigned). [Ref: from EAW0644]

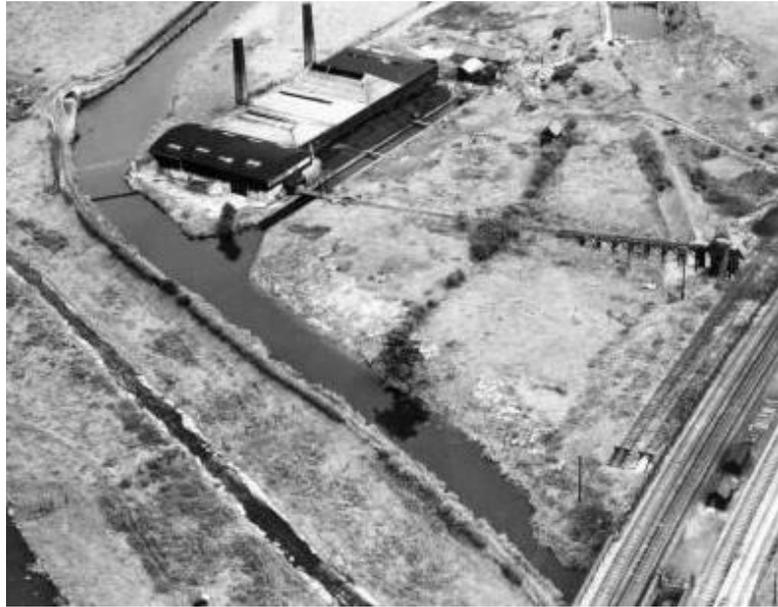
(b1) **Coming under the Railway Bridge** (100A) (lower right) along the Staffs & Worcs Canal from Radford, there is a straight section of canal, with the Salt Works Canal Arm ahead on the right and the brine pipe over the main canal beyond. The twin chimneys of the Salt Works will be in view. The Roving Bridge of the Stafford Branch Canal is probably just out of view initially. [Ref: from EAW0647]

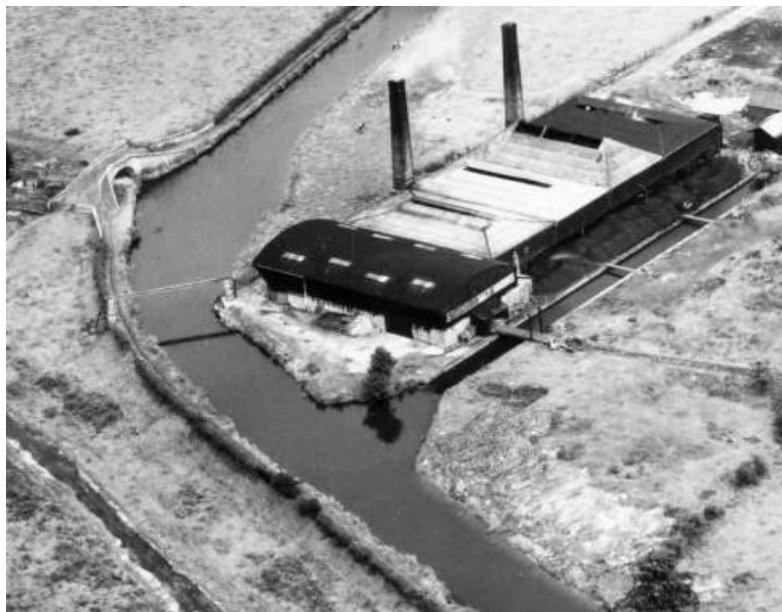
(b2) Further on, the Salt Works Canal Arm is now on the right and there is a clear view of the Salt Works. Once past this Arm, it will be underneath the brine pipe. The Roving Bridge will be in sight on the left and care would need to be taken negotiating the turn into the Branch Canal. The Towpath can be seen going under the Roving Bridge. There appears to be no signpost. Tom Rolt was here in 1939. There is no sign of traffic either in the Salt Arm or on the main canal. [Ref: from EAW0647]

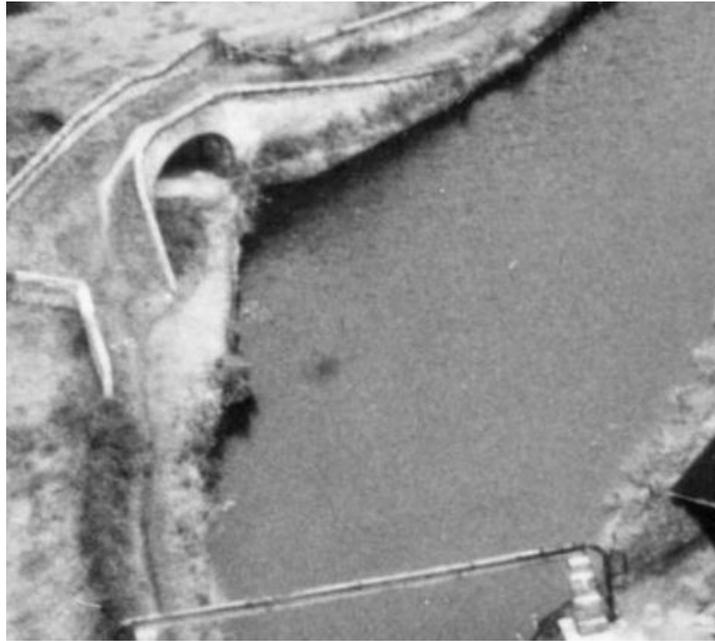
(b3) After the brine pipe, the Roving Bridge and entrance to the Branch Canal are on the left. The entrance was blocked-up to boats by the Staffs & Worcs Canal Company in 1929. The Towpath goes under the Roving Bridge and in 1951 walkers would have found their way barred by a gate. However, walkers using the towpath on the main canal would use the Roving Bridge to cross over the former Branch Canal. [Ref: from EAW0647]

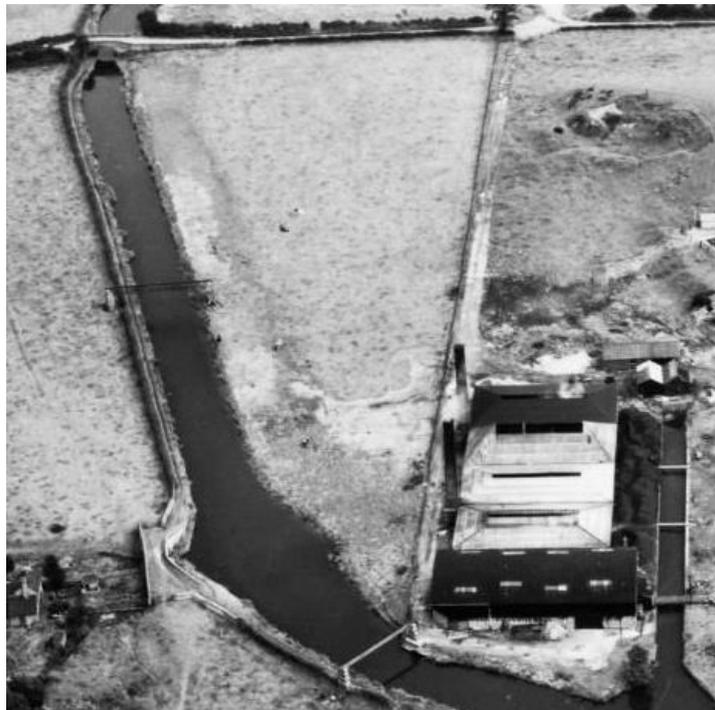
(b4) **Coming the other way** along the Staffs & Worcs Canal from Milford, underneath St Thomas' Bridge (101) (upper left) there is a straight section of canal with a brine pipe halfway down the straight. The Roving Bridge and entrance to the Branch Canal would be ahead on the right, with a second brine pipe beyond. Care would need to be taken negotiating the turn into the Branch Canal and the branch towpath would be on the left. [Ref: from EAW0652]

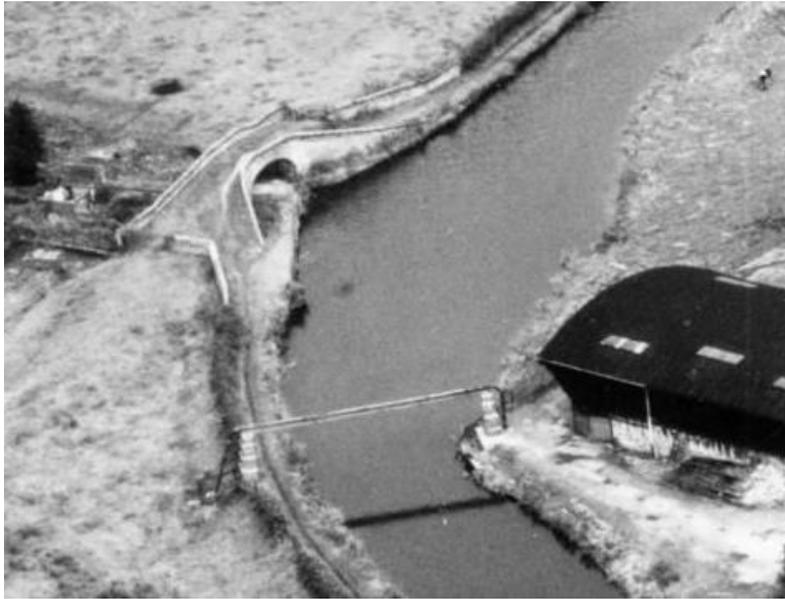
(c1) The Roving Bridge; approach to the Junction; pigsty in garden of Lock House visible on left and part of the Salt Works on right. Notice the pipe across the Staffs & Worcs Canal carrying brine to the Salt Works. [Ref: from EAW0647]

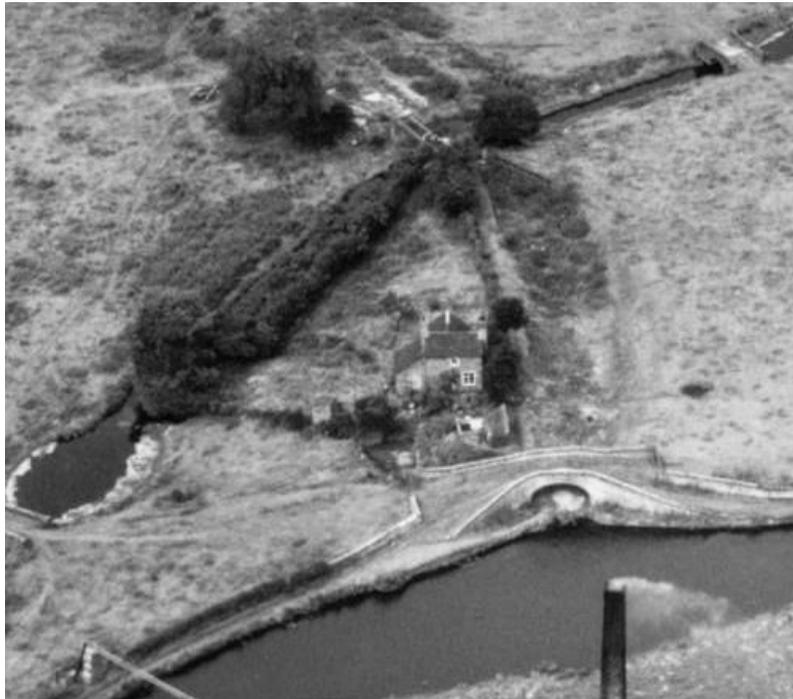
(c2) The Roving Bridge with Lock House & garden; pigsty and outside toilet. Site of former Basin visible, with towpath alongside leading to site of Aqueduct and Lock. The small bridge (upper right) goes over the Deepmoor Drain, as does the small bridge (lower left) which is just visible. The Aqueduct would have gone over the Deepmoor Drain too. [Ref: from EAW0654]

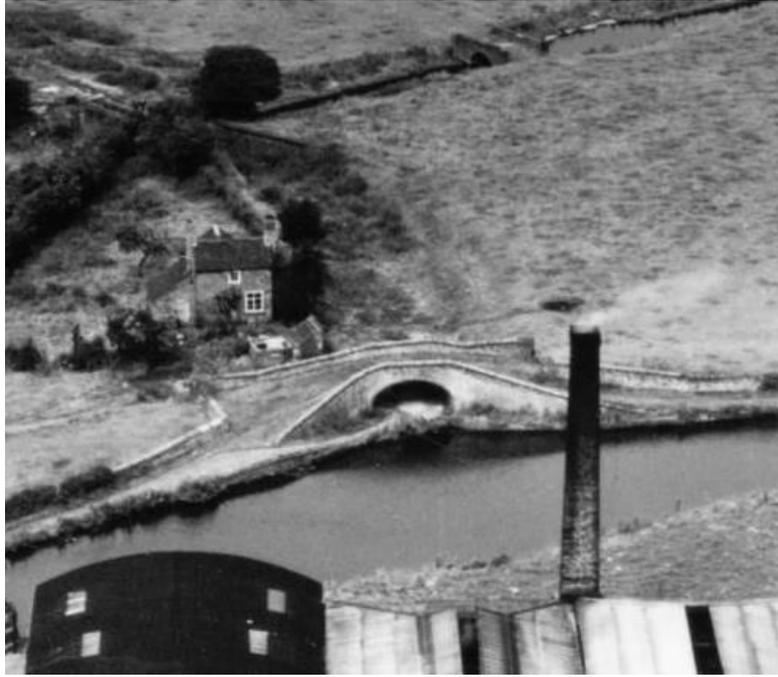
(c3) A closer view of the Roving Bridge, Lock House, pigsty, garden and former Basin. Notice that the Roving Bridge does not have a name plate or number; perhaps it had been removed or perhaps there never was one? [Ref: from EAW0646]

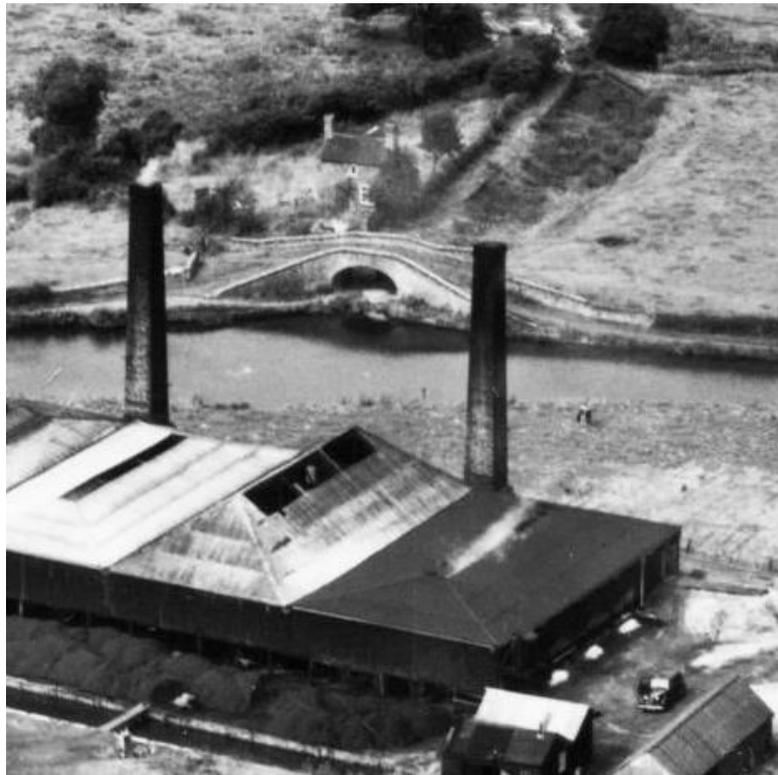
(c4) Twin chimneys of the Salt Works framing the Roving Bridge and Lock House. Good view of towpath and former Basin. Part of Salt Works Canal Arm is in the foreground. There is no signpost at the Junction; perhaps it had been removed or perhaps there never was one? [Ref: From EAW038643]

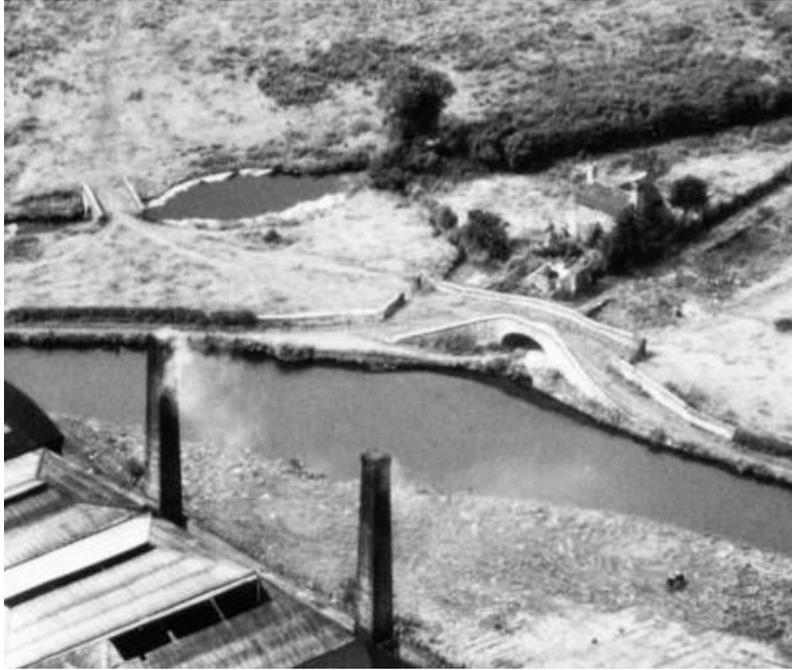
(c5) The Roving Bridge and Lock House with pigsty in front. The towpath and former Basin are to the right of Lock House. The small bridge (on the left) goes over the Deepmoor Drain. The sheep dip is just visible – please refer to Olive Price's map on page 4. [Ref: from EAW0653]

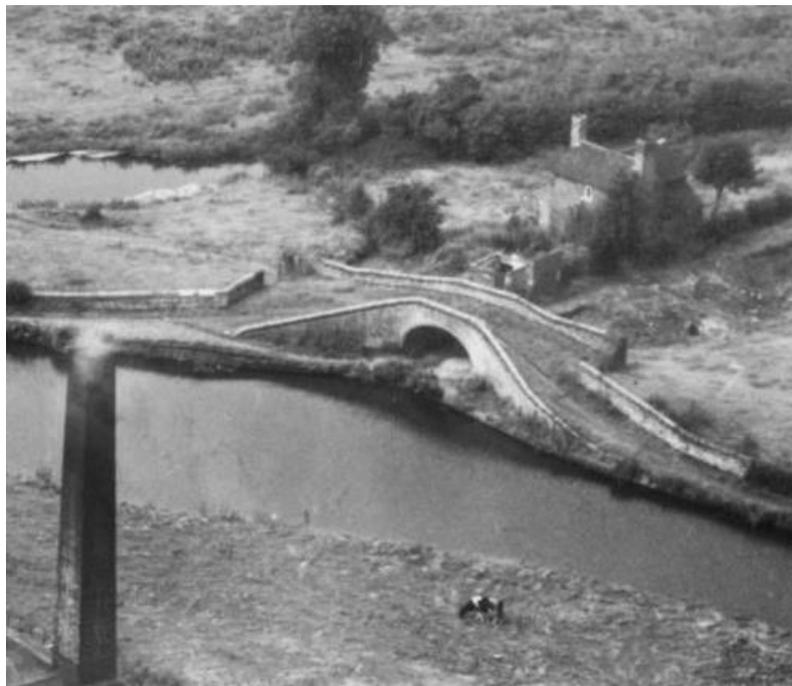
(c6) The photograph clearly shows how the Roving Bridge was constructed. The Lock House with pigsty in front, hawthorn hedge, towpath and former Basin to the right. Notice the path crossing the former Basin and going between the hawthorn hedge and the pigsty wall. The outside toilet is visible (just above centre). [Ref: From EAW0648]

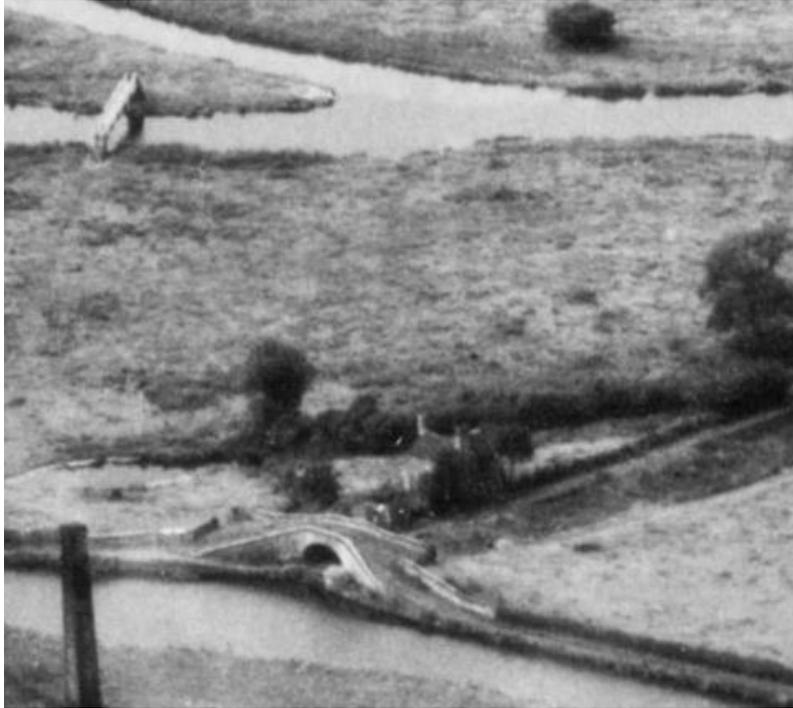
(c7) The Roving Bridge, former Basin and Lock House. The junction of the Rivers Sow and Penk is clearly seen. The footbridge goes over the River Penk and a path leads towards the Lock House. After the Rivers Sow and Penk were realigned here, the footbridge found itself stranded in a field and some people now refer to it as “the bridge in the middle of nowhere”. [Ref: from EAW0644]

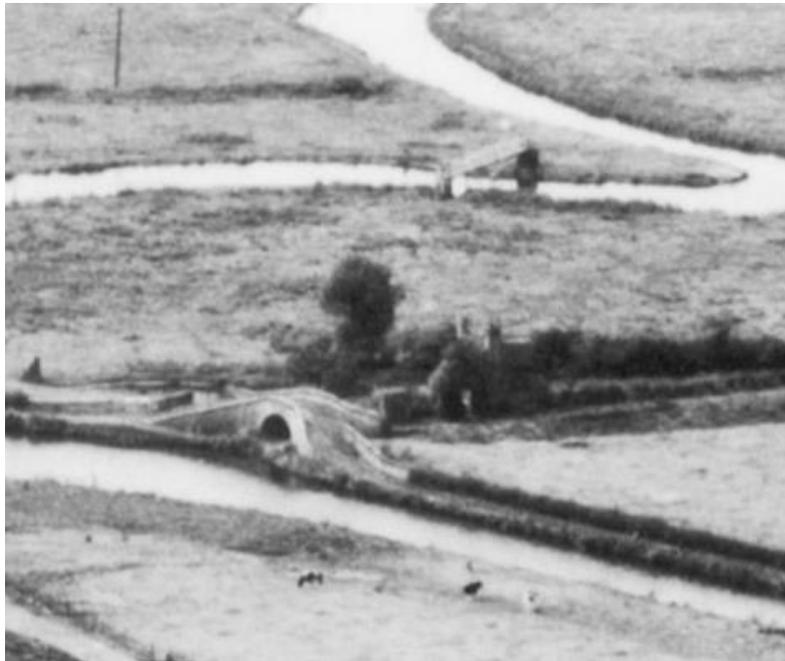
(c8) Another view of the Roving Bridge and Lock House, with footbridge over the River Penk, and the River Sow beyond. [Ref: From EAW0645]

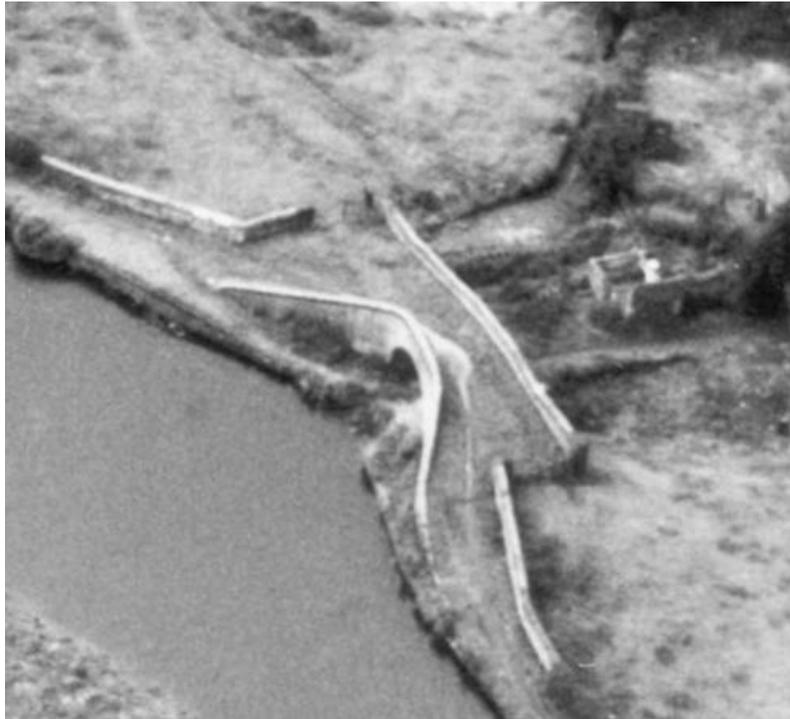
(c9) An excellent view of the Roving Bridge. Walkers keeping to the main line of the Staffs & Worcs Canal would use the Roving Bridge to cross the Branch Canal, while the Branch Canal would be accessed using the towpath going under the left hand side of the Roving Bridge. Notice the two wooden gates on the Bridge, allowing farmers to access the land either side of the Branch Canal. The pigsty is clearly visible, as is the water coming from the Overflow Weir (upper centre, to right of Roving Bridge). The main Canal is also wider here to facilitate boats turning. [Ref: From EAW0651]

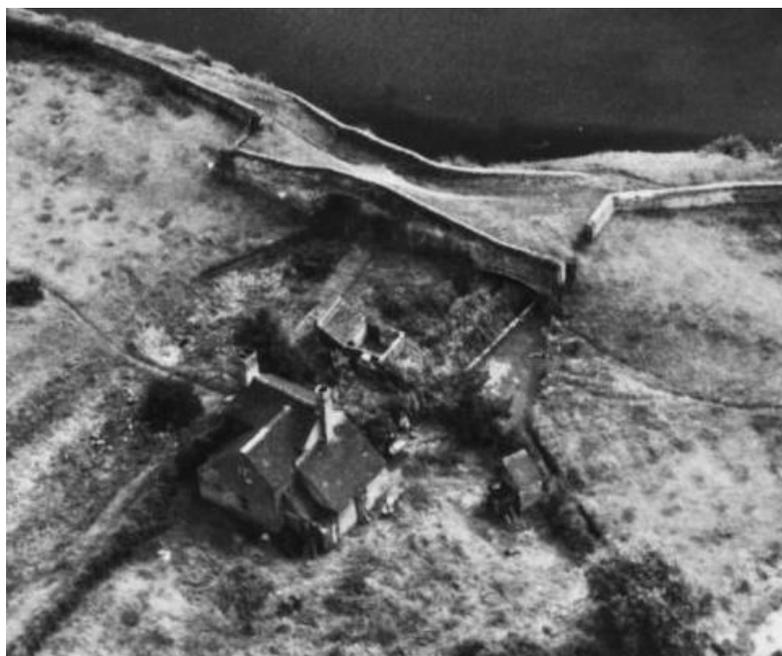
(c10) The Roving Bridge, Lock House, pigsty, well and outside toilet; and Overflow Weir. The former Basin leads to the bridge hole and the Staffs & Worcs Canal. Notice the path (centre left) over the Basin leading across the field towards Baswich Lane. [Ref: From EAW0649]

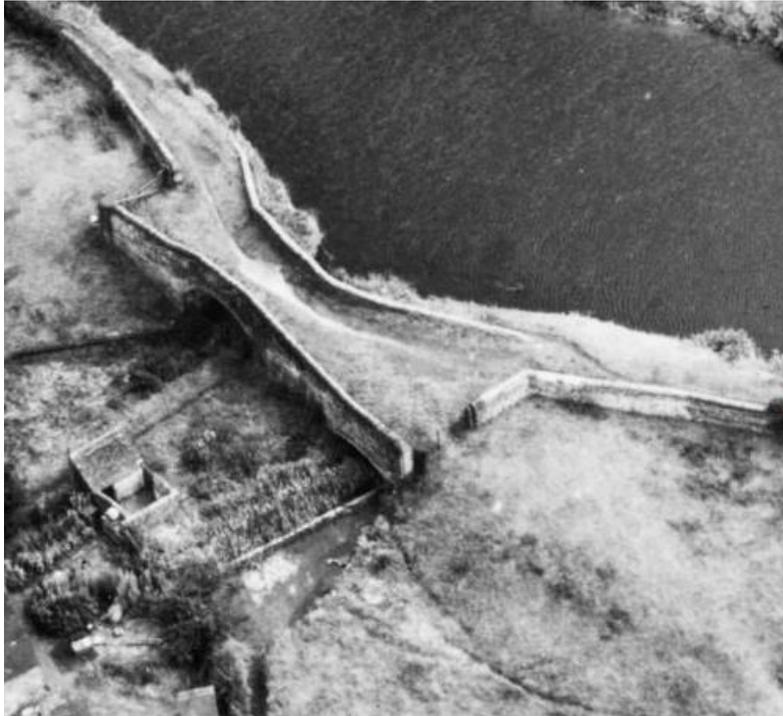
(c11) A closer view of the Roving Bridge, with pigsty, well, Overflow Weir, roof of outside toilet (lower left of centre) and part of the Lock House (lower far left). [Ref: From EAW0650]

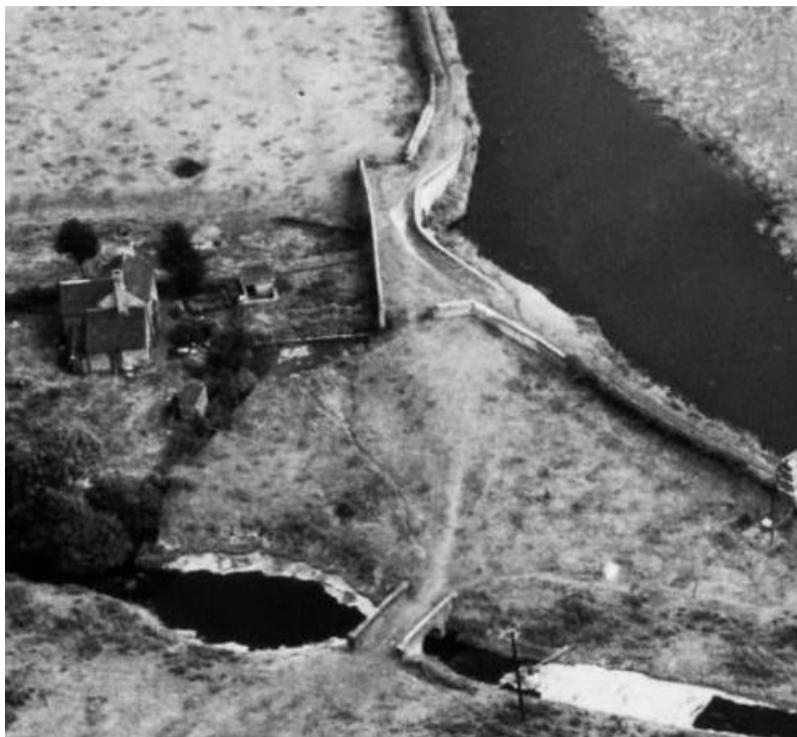
(c12) Roving Bridge with Overflow Weir and channel leading to the Deepmoor Drain. The Lock House, pigsty, well and outside toilet are all visible. The small bridge in the foreground crosses the Deepmoor Drain. The brine pipe is seen on the right. [Ref: From EAW0652]

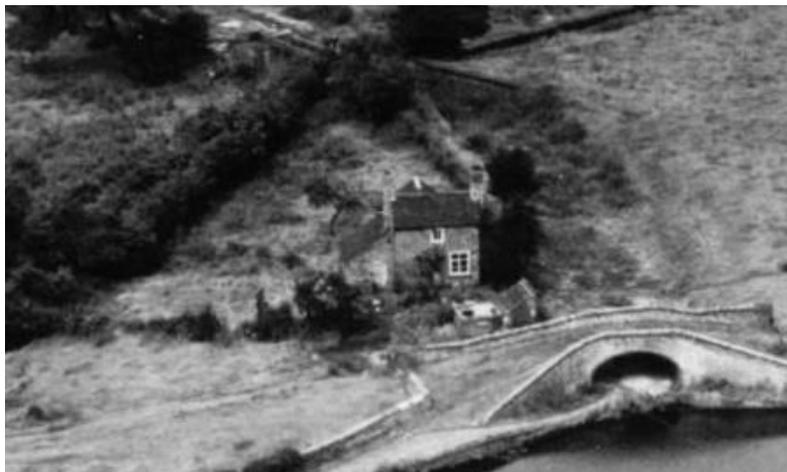
(d1) The front of the Lock House. To the right of the front door is the Living Room window, and above the door is the window to the Front Bedroom. The single-storey Washhouse is on the left with the sloping roof. The Pigsty is between the house and the Roving Bridge. The garden at the rear tapers towards the site of the former Aqueduct and Lock. [Ref: From EAW0646]

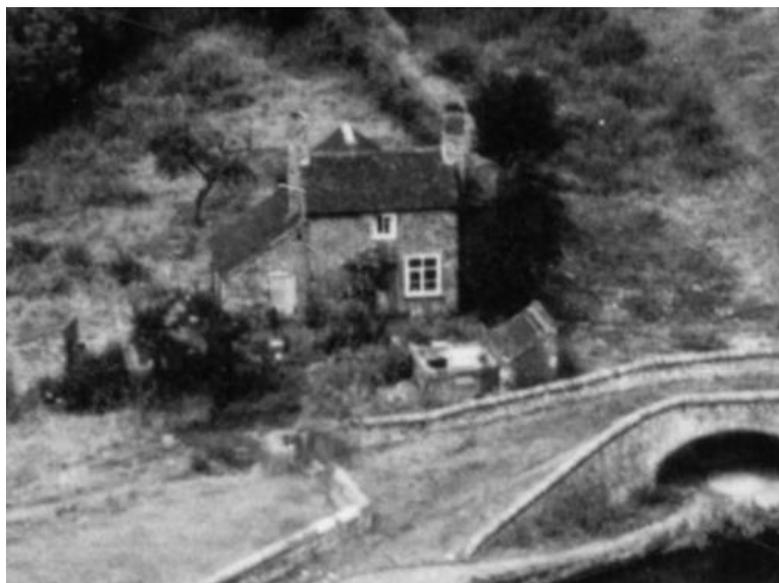
(d2) A closer view of the front of the Lock House. To the right of the front door is the Living Room window, and above the door is the window to the Front Bedroom. The Washhouse is on the left with the sloping roof made of slates; the Washhouse door is also at the front and it faces the Well with hand water pump. The outside toilet, also with a sloping roof, is visible on the left. The Pigsty is between the house and the Roving Bridge. There were two parts to the Pigsty; there was a brick enclosure, which had a covered area with a slate roof, and an open area. [Ref: From EAW0646]

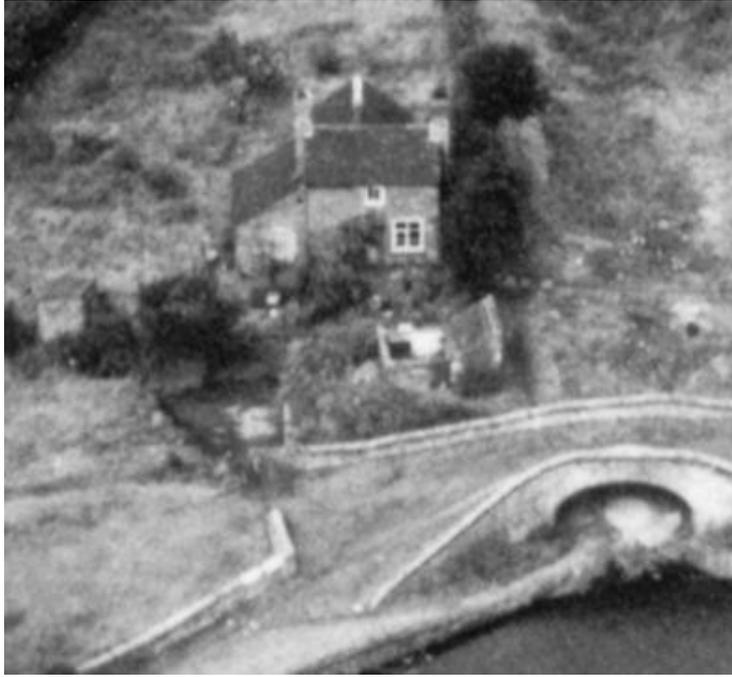
(d3) A close-up view of the front of the Lock House. To the right of the front door is the Living Room window, and above the door is the window to the Front Bedroom. The Washhouse is on the left with the sloping roof made of slates; the Washhouse door faces the Well with hand water pump. Ahead, towards the Roving Bridge, is the Overflow Weir. On the left is the outside toilet. The Pigsty is to the right of the Overflow Weir, between the house and the Roving Bridge. There were two parts to the Pigsty; there was a brick enclosure, which had a covered area with a slate roof, and an open area.  
[Ref: From EAW0654]

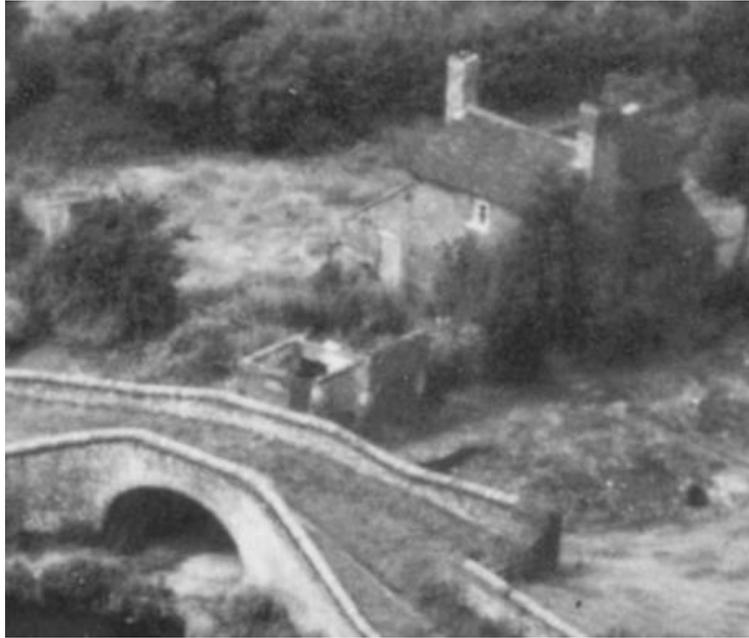
(d5) A good view of the Lock House, pigsty and outside toilet. The single towpath from the Staffs & Worcs Canal goes underneath the Roving Bridge on the left. Just through the Roving Bridge was a wooden fence across the old channel and a metal 'wicket gate' across the towpath. On the left was the wall of the pigsty, and then came a wooden fence. Next, on the left, was a gate that opened into the garden where a path led to the front of the Lock House; notice, that going the other way, the path went over the in-filled Basin to head across the field towards Baswich Lane. [Ref: From EAW0648]

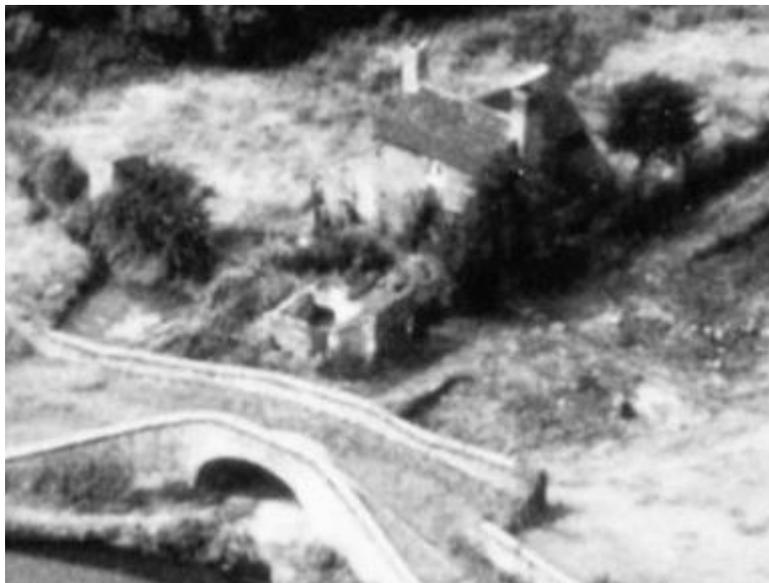
(d6) The Lock House, with pigsty between the house and the Roving Bridge, the Overflow Weir and the outside toilet. The Lock House had two chimneys; one (on the right) served the Cooking Range in the downstairs Living Room and the front bedroom on the upper floor; the other (on the left) was for the copper boiler in the Washhouse. [Ref: From EAW0653]

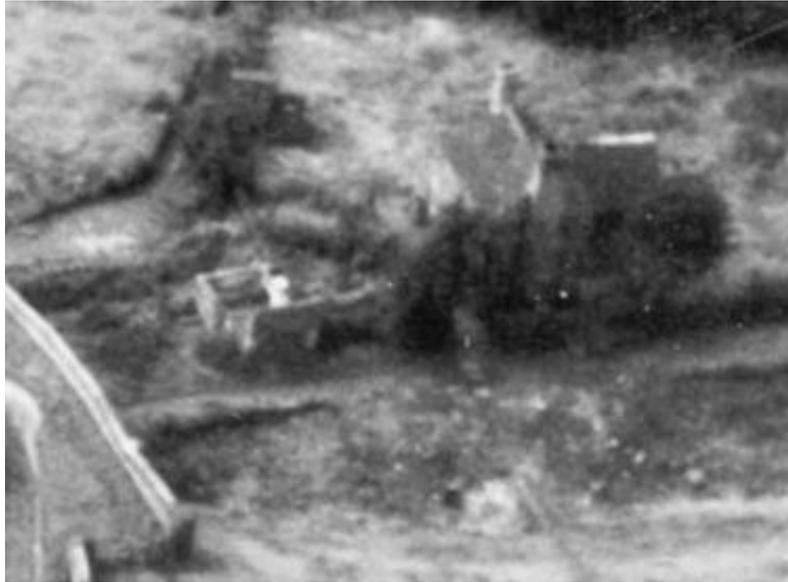
(d7) Looking west, the east side of the Lock House, with pigsty, Overflow Weir and outside toilet. The towpath runs alongside the in-filled Basin. The east wall of the Lock House doesn't have any windows overlooking the Basin. Notice the path crossing the Basin, then across the towpath before passing in front of the Lock House. Part of the Roving Bridge is at the lower right. [Ref: From EAW0651]

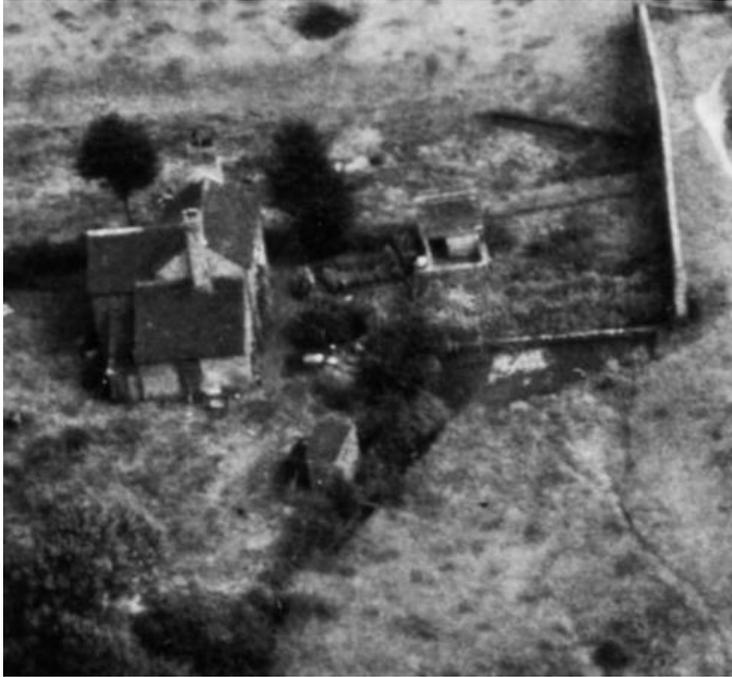
(d9) View of the Lock House looking east; the Washhouse with entrance door is clearly seen and the chimney serves the copper boiler inside. There is a small storage area to the left of the Washhouse. There is a good view of the layout of the area at the front of the Lock House facing the Roving Bridge: pigsty, well, the Overflow Weir, outside toilet and the various paths. [Ref: From EAW0652]

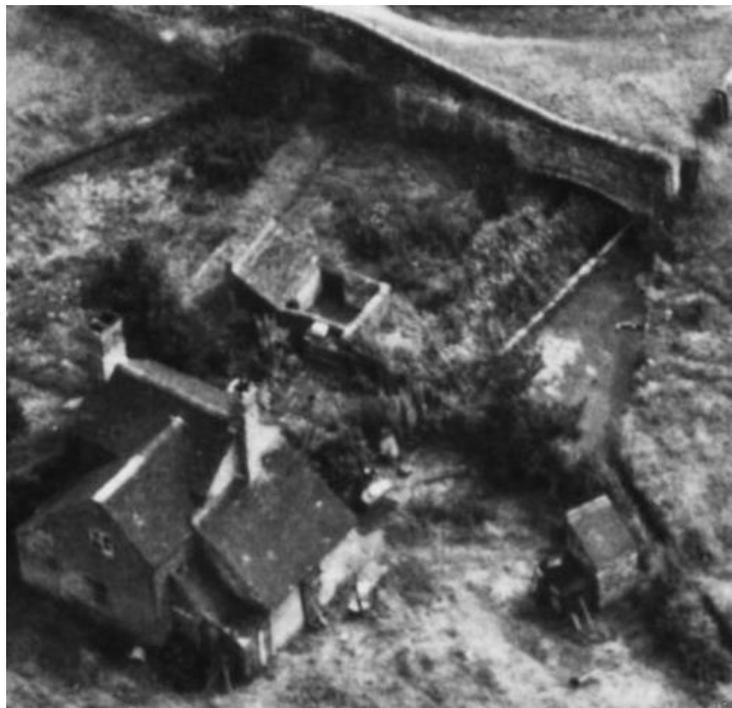
(d10) An excellent view of the Lock House Site facing the Roving Bridge (pigsty, Overflow Weir and drainage channel, the well and the outside toilet) and also the north side (back) of the Lock House: there are three windows: one window on the upper floor (Back Bedroom), another window below (Back Kitchen) and the Pantry window to the left of this. [Ref: From EAW0649]

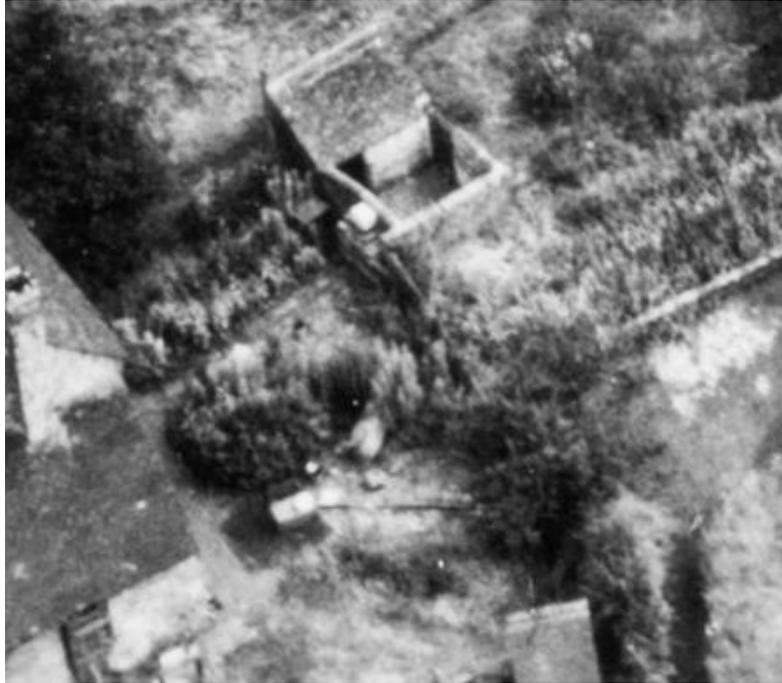
(d11) Close-up view of the Well (lower centre) in the front garden of the Lock House. The roof of outside toilet is at the lower right, the pigsty in the upper centre and the Overflow Weir to the right of centre. [Ref: From EAW0650]

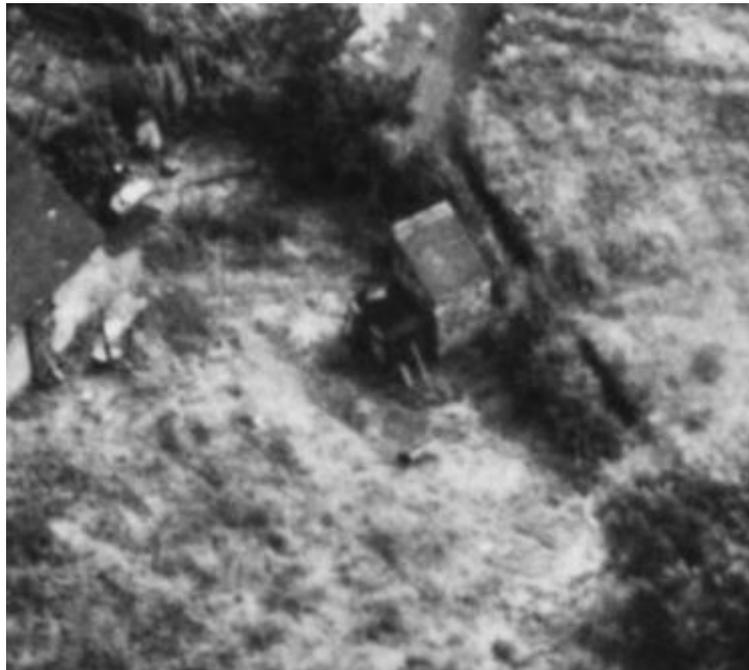
(d12) Close-up of the outside toilet (centre). It was built of red brick and probably had a slate roof. Inside, the toilet consisted of a wooden plank bench seat and in the 1940s/1950s was emptied weekly. The toilet door is not visible as it is in the apex wall furthest away from the camera. Part of the Washhouse is on the left and the Washhouse door is visible. [Ref: From EAW0649]

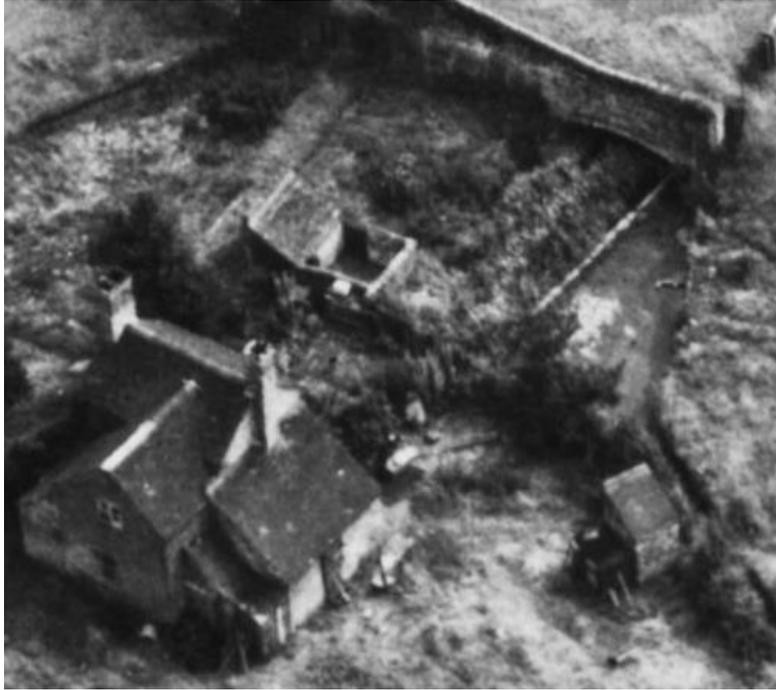
(e1) An excellent view of the features around the Lock House. The Overflow Weir is on the right and the channel directs water to the right of the Outside Toilet. [Ref: From EAW0649]

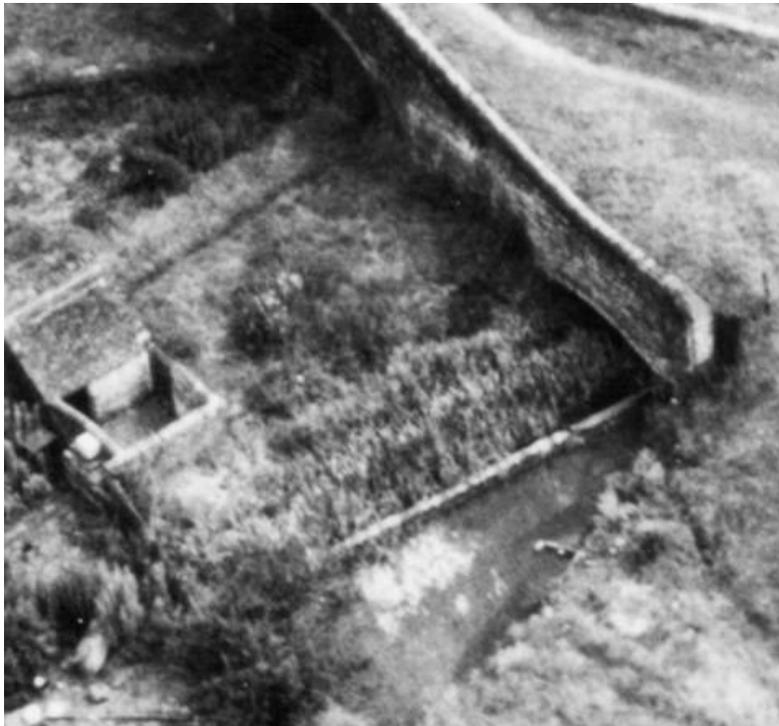
(e2) A close-up picture of the Overflow Weir. The pigsty is to the right, with grass in front to the Roving Bridge. [Ref: From EAW0650]

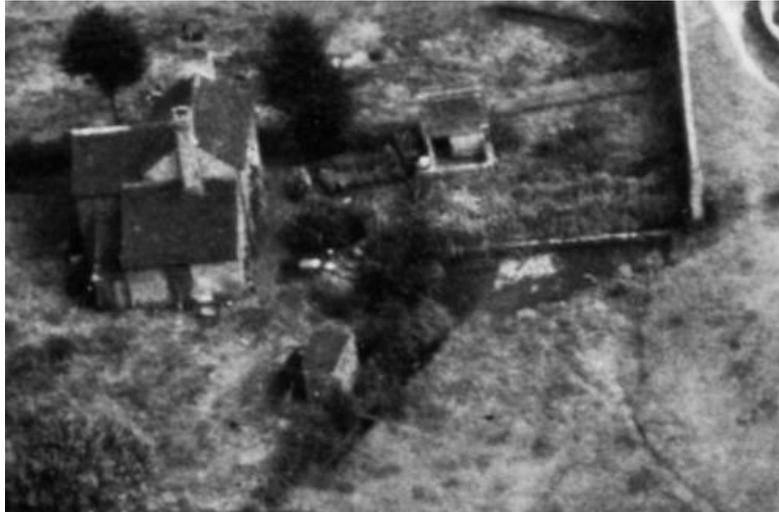
(e3) The Overflow Weir is to the right of centre of the picture and a channel leads water away to the right of the outside toilet. [Ref: From EAW0652]

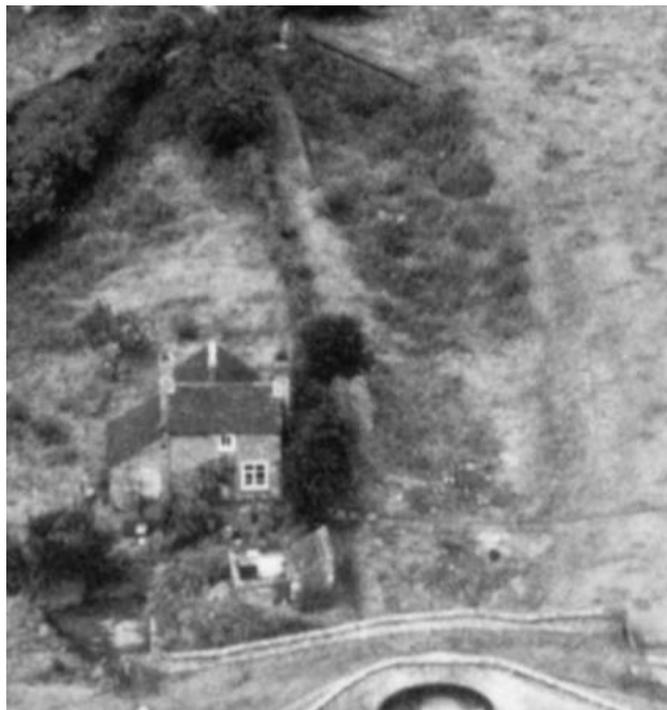
(f1) The former Basin, with towpath alongside (on the left) stretching from the Roving Bridge and leading to former Aqueduct and Lock. Between the Lock House and the pigsty is a garden path; the path crosses the towpath, goes straight over the (mainly) filled-in Basin, then across the field to the gate onto Baswich Lane. [Ref: From EAW0654]

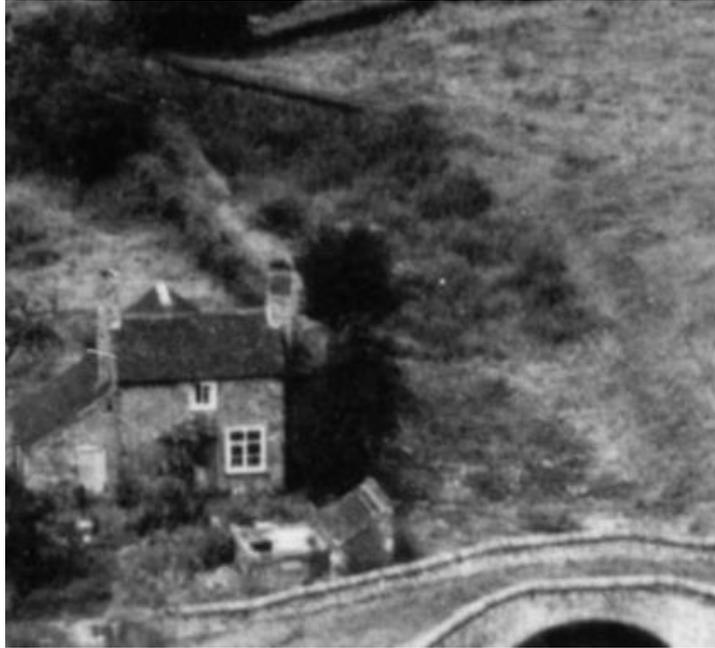
(f2) The former Basin, stone-edged on the left but turf-sided on the right except on the approach to the former aqueduct where both sides have stone edges. Good view of the Lock House and pigsty, and the path between them leading over the Basin to the field. [Ref: From EAW0646]

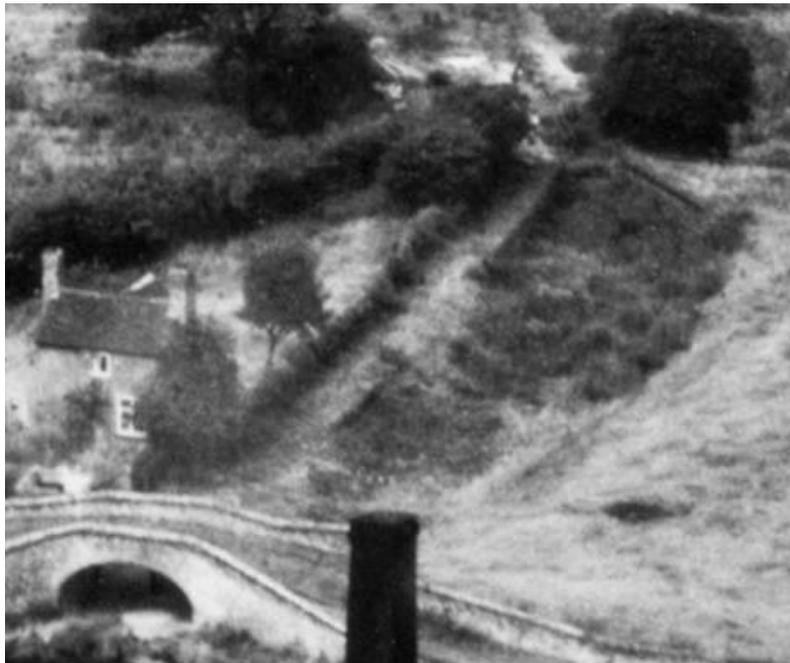
(f3) The former Basin and towpath are separated by the hawthorn hedge from the Lock House and garden. The Basin has stone edges on the left but is turf-sided on the right except in the section leading to the entrance of the former Aqueduct where both sides have stone edges. [Ref: From EAW0643]

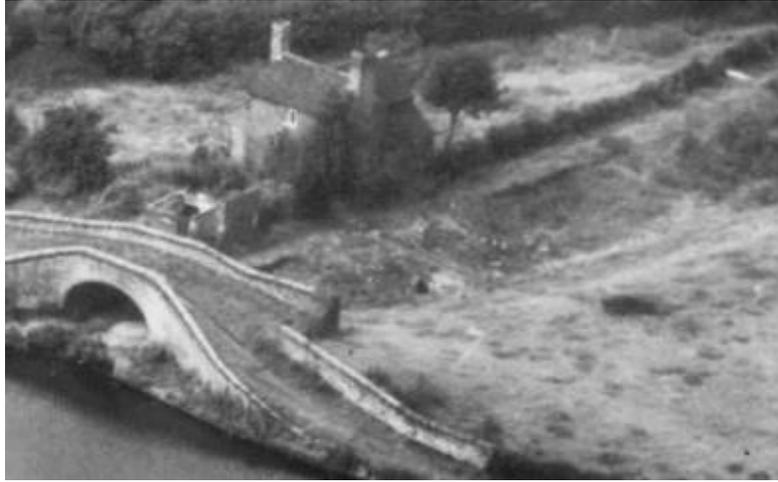
(f4) The former Basin and towpath are separated by the hawthorn hedge from the Lock House and garden. The Basin has stone edges on the left but is turf-sided on the right except in the section leading to the entrance of the former Aqueduct where both sides have stone edges. The path from the Lock House goes over the towpath, which then crosses the Basin before heading across the field towards Baswich Lane and nearest neighbours. [Ref: From EAW0648]

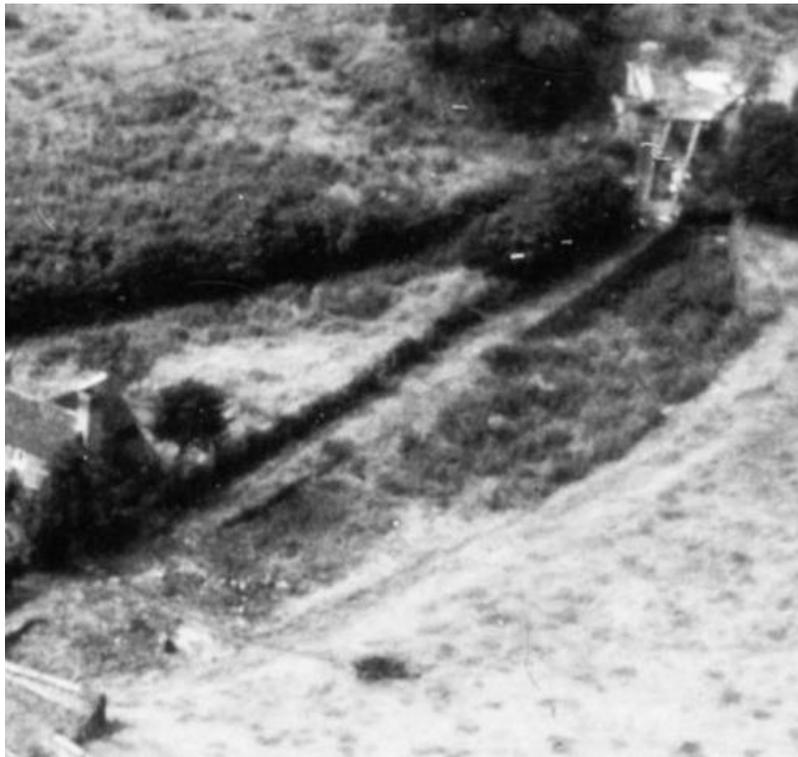
(f5) The former Branch Canal Basin (with towpath and hawthorn hedge to the left) leading to the site of the former Aqueduct and Lock. The Lock House is on the left and the path, from the garden gate, goes across the bed of the Basin. Part of the Roving Bridge is at the lower left. [Ref: From EAW0653]

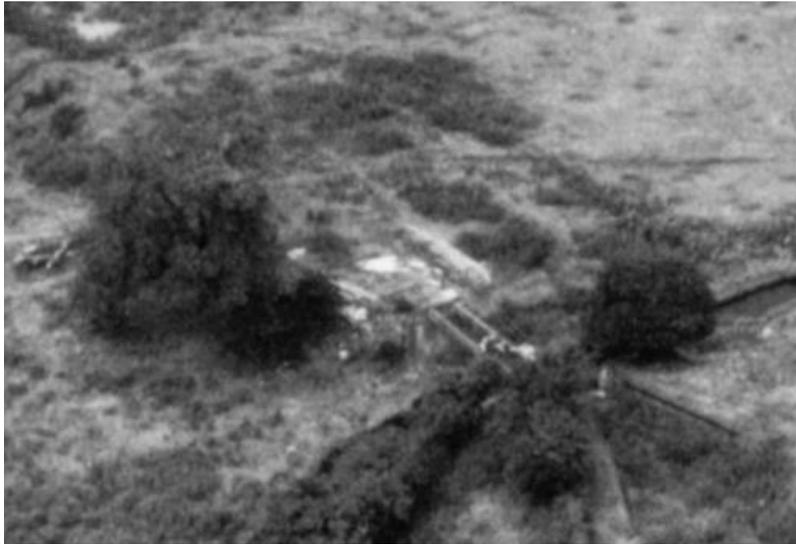
(g1) At the lower right, the Basin leads to the site of the Aqueduct and Lock. The Lock was demolished in 1935 and the cast-iron trough Aqueduct is no longer in place, although the wooden bridge alongside can be seen. It is not clear how best to fully interpret this image. [Ref: From EAW0654]

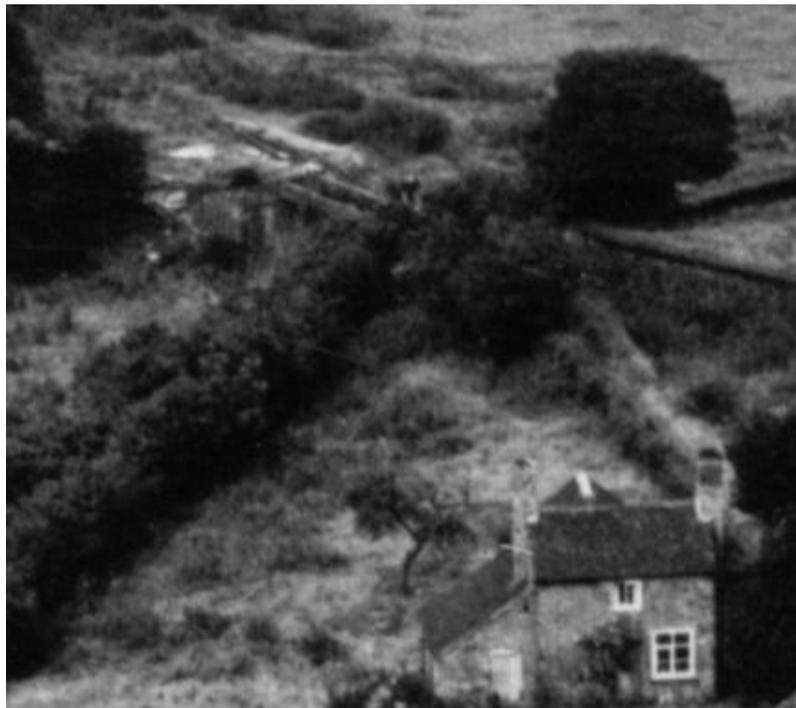
(g2) The Basin leads to the site of the Aqueduct and Lock. The Lock was demolished in 1935 and the cast-iron trough Aqueduct is no longer in place, although the wooden bridge alongside can be seen. It is not yet clear how best to fully interpret this image. [Ref: From EAW0646]
