**PHOTOGRAPHS OF THE STAFFORD BRANCH CANAL**  
**AT BASWICH (ST THOMAS') IN 1951**

**Introduction**

*Britain from Above* have twenty images on their Website of the former Baswich Salt Works. The images were taken on 14 August 1951 and uploaded in 2014.

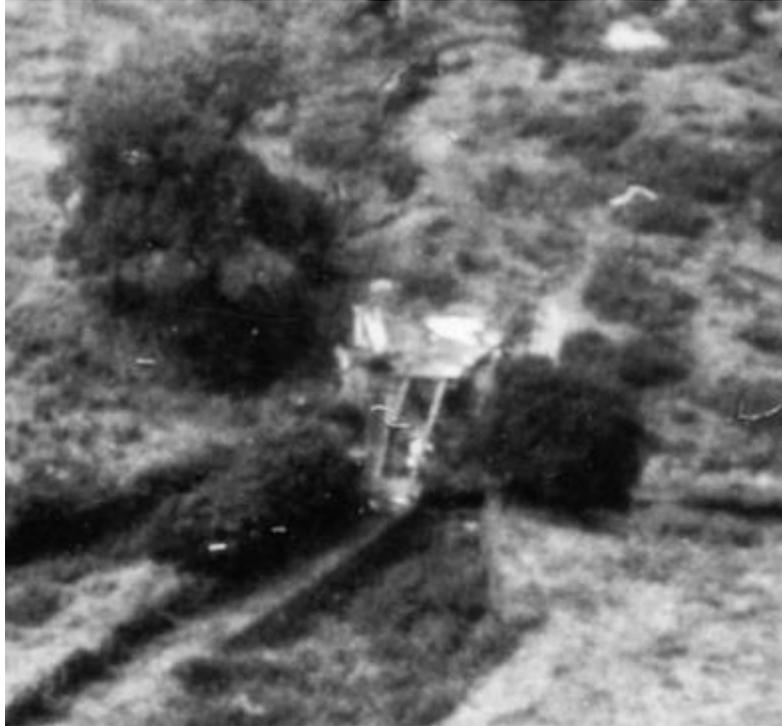
(g3) The Basin funnels to the site of the Aqueduct and Lock. The wooden bridge alongside the empty aqueduct channel goes over the Deepmoor Drain. [Ref: From EAW0653]

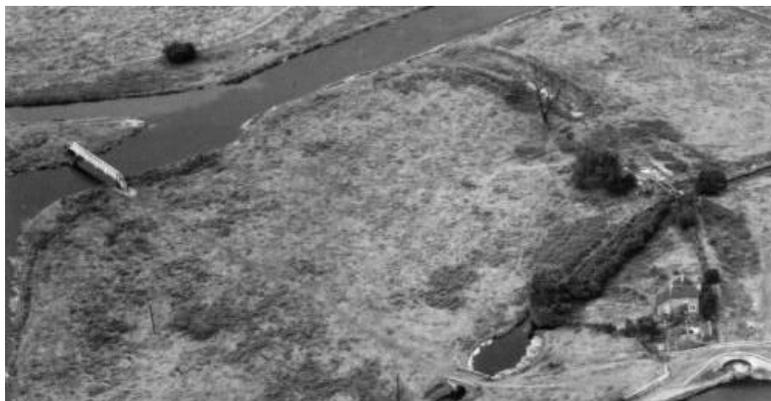
(h1) An overview of the Baswich Site. Staffs & Worcs Canal in the lower right with the Roving Bridge at the entrance to the Stafford Branch Canal and the Lock House on the left. The Basin leads to the site of the Aqueduct and Lock, after which the largely in-filled channel of the former Navigation can be seen heading towards the River Sow. The footbridge on the left spans the River Penk. When the Navigation was operational, boats would turn left from the Branch Canal and follow the River Sow (passing the former Ladder Bridge at the entrance to the River Penk, used as the towpath) to the Coal Wharf by Green Bridge in the centre of Stafford. [Ref: From EAW0654]

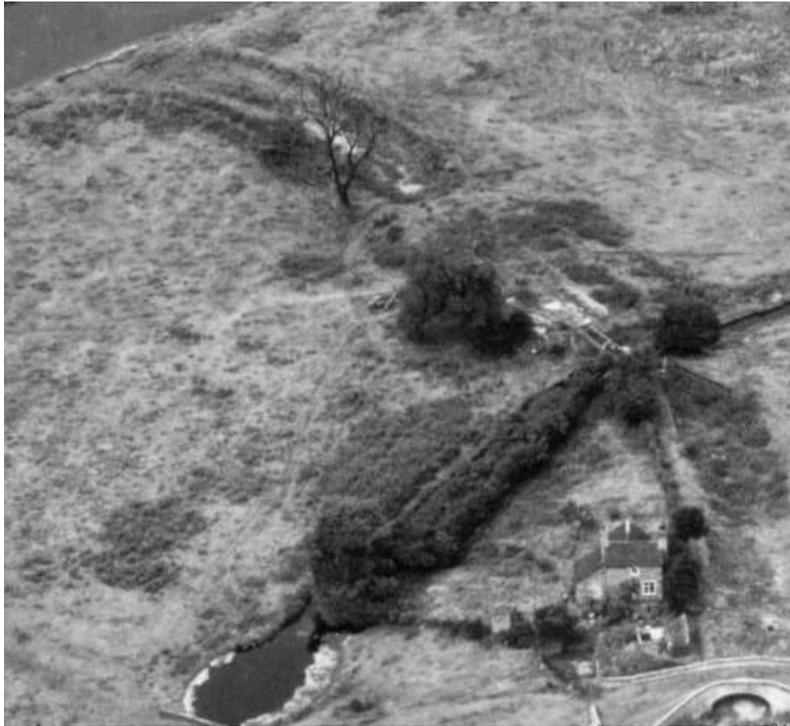
(h2) A closer view of the route of the former Stafford Branch Canal connecting the Staffs & Worcs Canal to the River Sow. This was the section of the River Sow Navigation that Omar Hall did not get permission to connect to the Staffs & Worcs Canal from the Staffs & Worcs Canal Company (1811/1812). [Ref: From EAW0654]

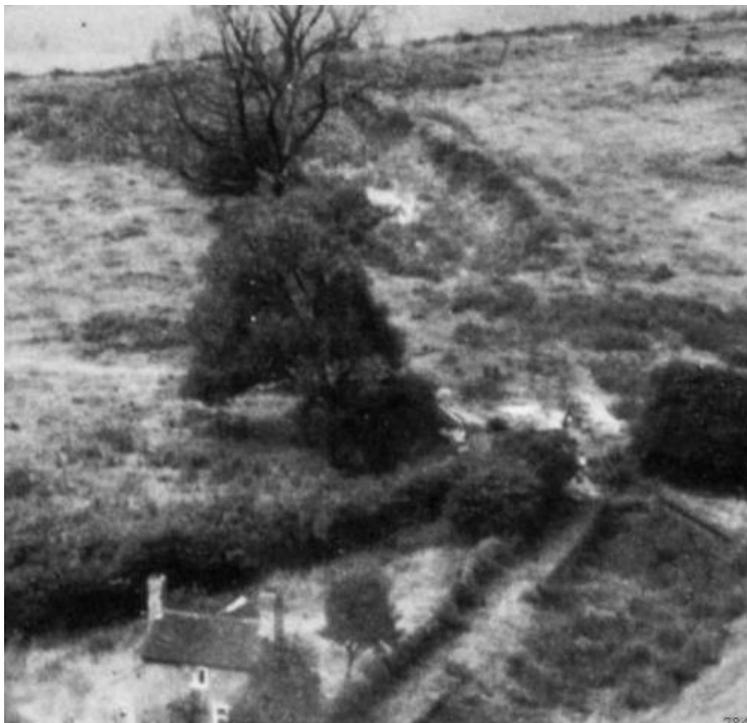
(h3) Another view of the route of the former Stafford Branch Canal connecting the Staffs & Worcs Canal to the River Sow. The approach to the former Aqueduct and Lock is clear. [Ref: From EAW0643]

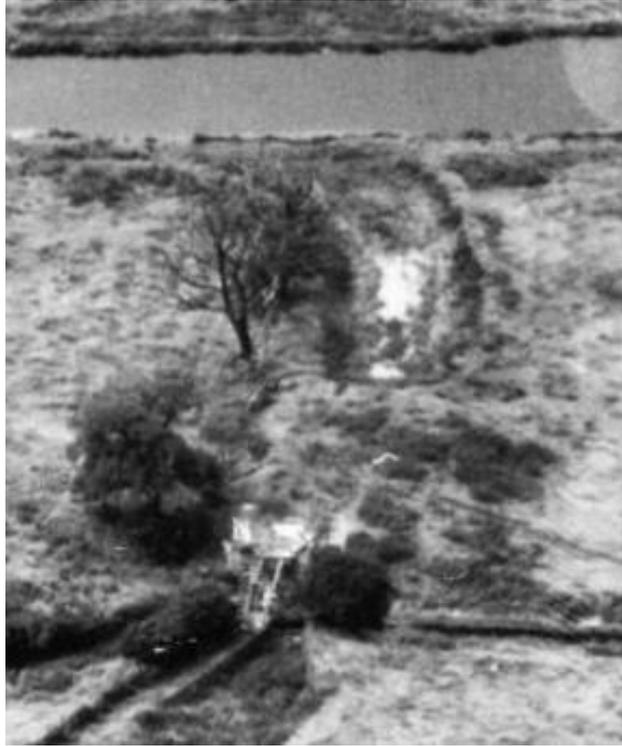
(h4) A much closer view of the route of the Stafford Branch Canal from the site of the Aqueduct and Lock to the River Sow. The wooden footbridge alongside the empty aqueduct channel goes over the Deepmoor Drain. [Ref: From EAW0653]

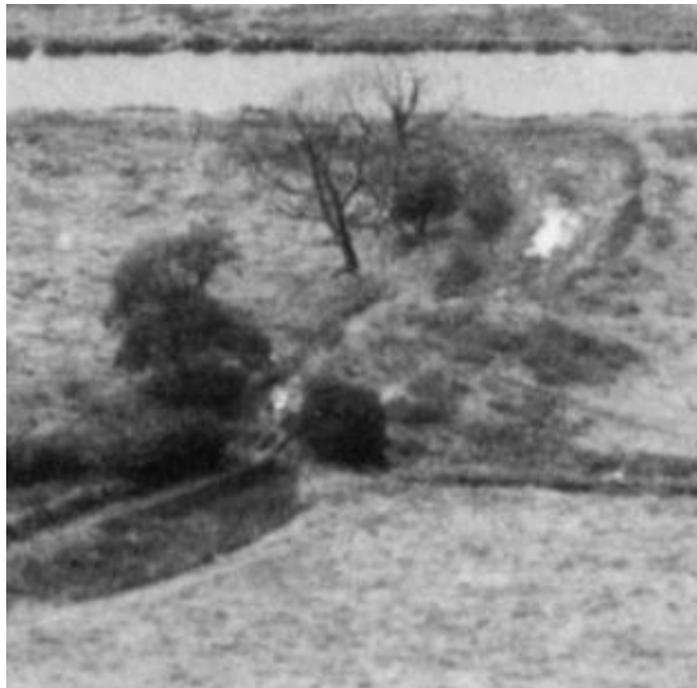
(h5) Another view of the route of the Stafford Branch Canal from the site of the Aqueduct and Lock to the River Sow. Boats would have turned left and followed the River Sow to Stafford. [Ref: From EAW0644]

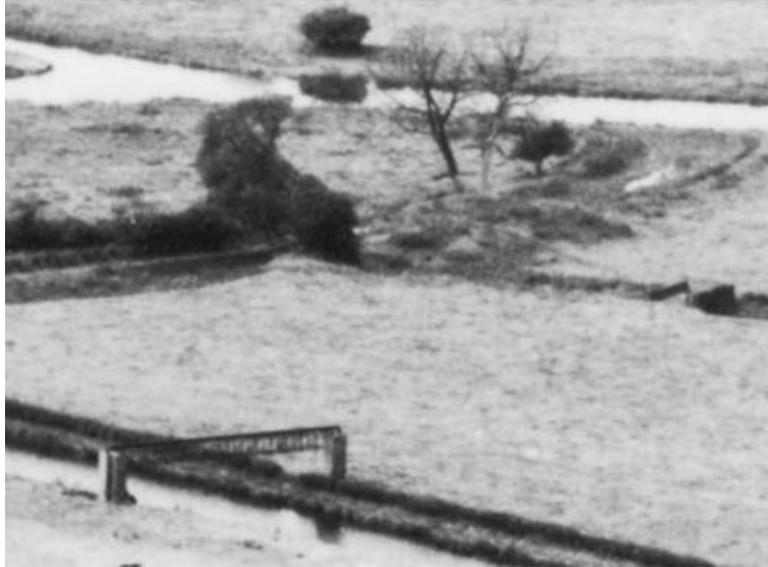
(h6) Another view of the route of the Stafford Branch Canal from the site of the Aqueduct and Lock to the River Sow. The pipe over the Staffs & Worcs Canal in the foreground carries brine to the Salt Works. The River Sow (in the background) flows west to east (left to right), so boats travelling to Stafford would be going against the flow. The junction with the River Penk is at the top left of the picture. [Ref: From EAW0645]

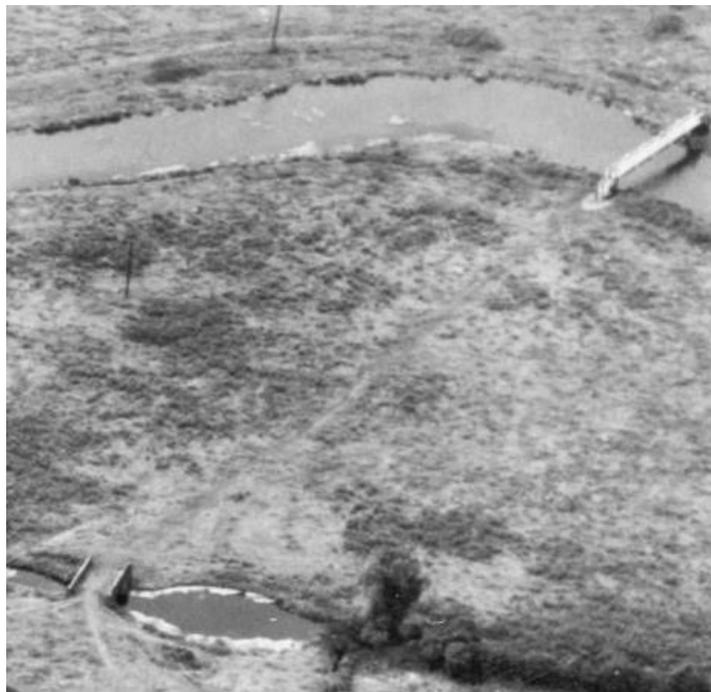
(i1) In the foreground the small bridge goes over the Deepmoor Drain, while the footbridge in the upper right of the picture goes over the River Penk. Notice the footpath connecting the two. [Ref: From EAW0651]

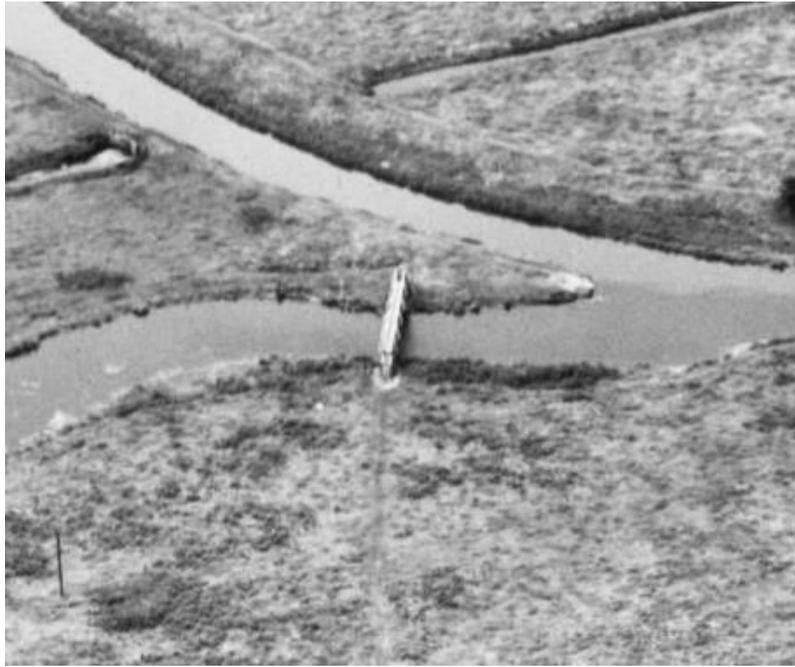
(i4) The footbridge over the River Penk close to the junction with the River Sow. It was probably built in the 1940s and replaced the Ladder Bridge, used as the Navigation's towpath, which was sited further to the right (east) at the junction of the Rivers Sow and Penk. [Ref: From EAW0653]

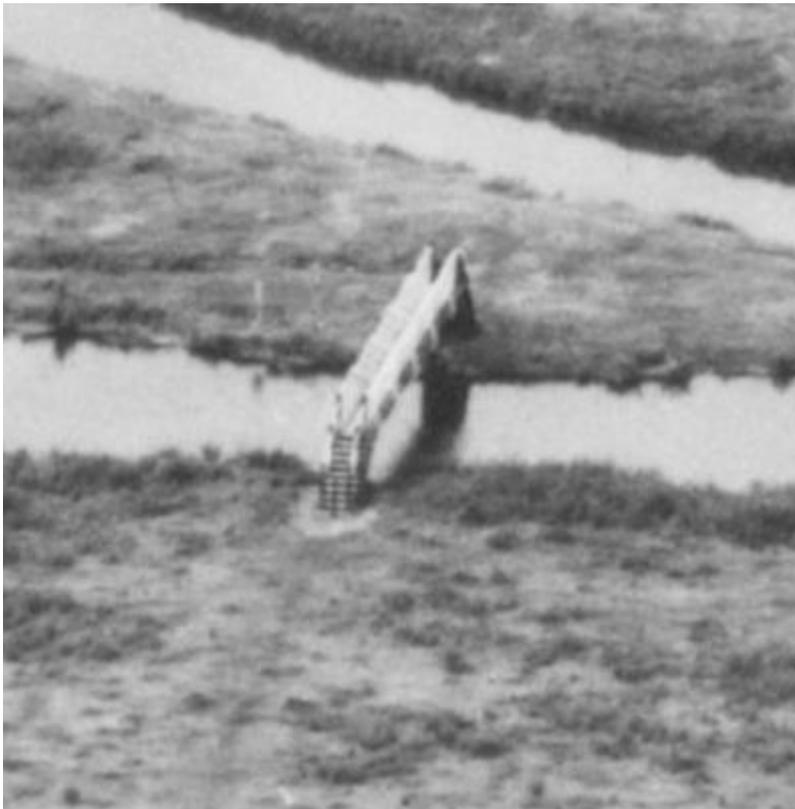
(i5) The footbridge over the River Penk. Notice the steps of the bridge. [Ref: From EAW0648]

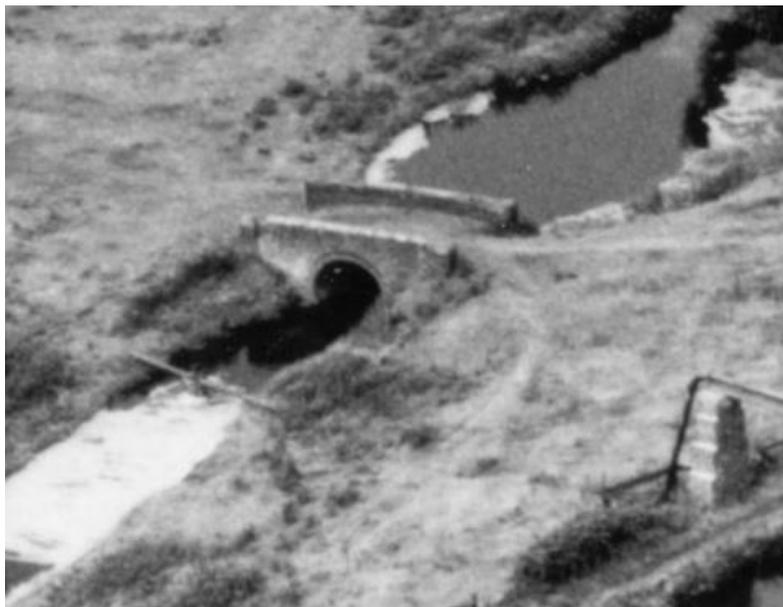
(i6) A closer view of the small bridge over the Deepmoor Drain. Part of a brine pipe over the Staffs and Worcs Canal is at the lower right. [Ref: From EAW0646]

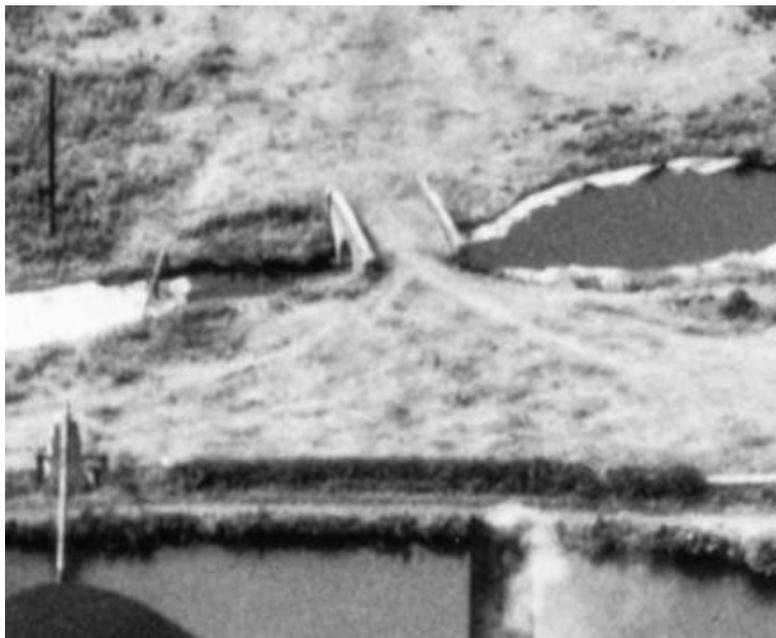
(i11) The small bridge over the Deepmoor Drain is in the centre of the picture; the Staffs & Worcs Canal is in the foreground and the brine pipe is on the left. The sheep dip is visible - almost at the extreme right of the picture, between the path and the wide section of the Deepmoor Drain. [Ref: From EAW0653]

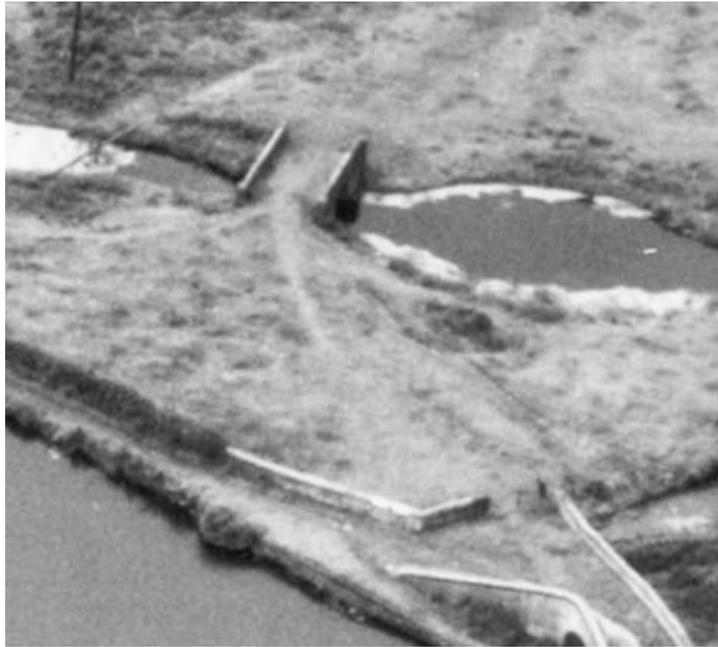
(i12) The small bridge over the Deepmoor Drain with path leading to the Roving Bridge. A very good view of the sheep dip which is just to the right of centre - please refer to Olive Price's map on page 4. [Ref: From EAW0651]

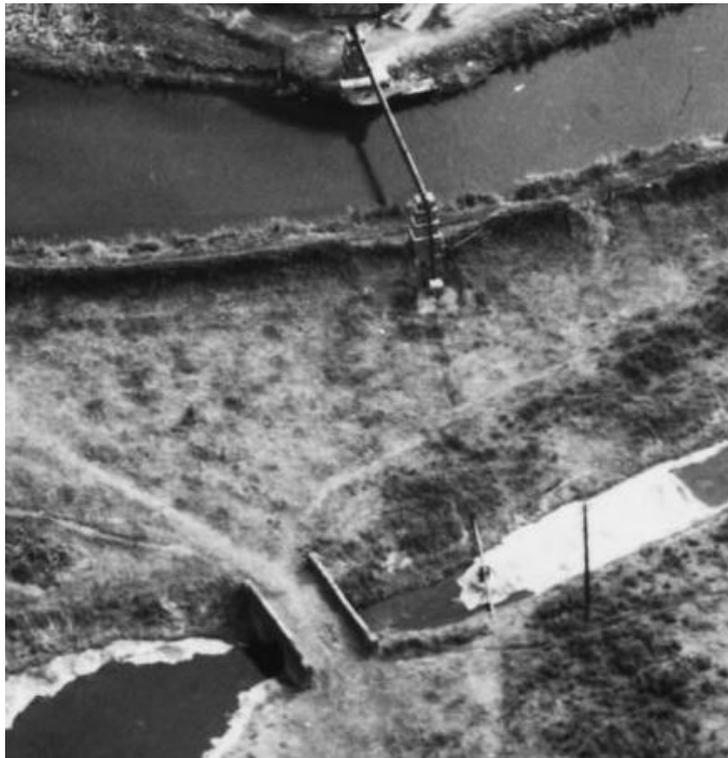
(i13) The small bridge goes over the Deepmoor Drain. Good view of the brine pipe crossing the Staffs & Worcs Canal (upper centre). The sheep dip is on the extreme left, between the wide section of the Deepmoor Drain and the minor path to the left of the small bridge. [Ref: From EAW0649]

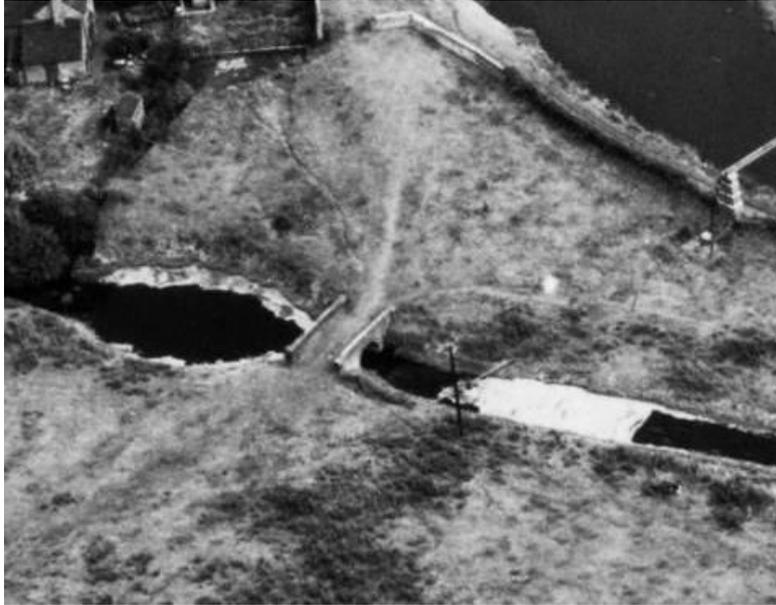
(i14) The small bridge goes over the Deepmoor Drain with the path leading to the Roving Bridge (top of picture). The Lock House is at the top left, with the Washhouse closest. The outside toilet is visible, as is the Overflow Weir. Notice the small path going over a very small bridge across the overflow channel leading to the outside toilet. [Ref: From EAW0652]

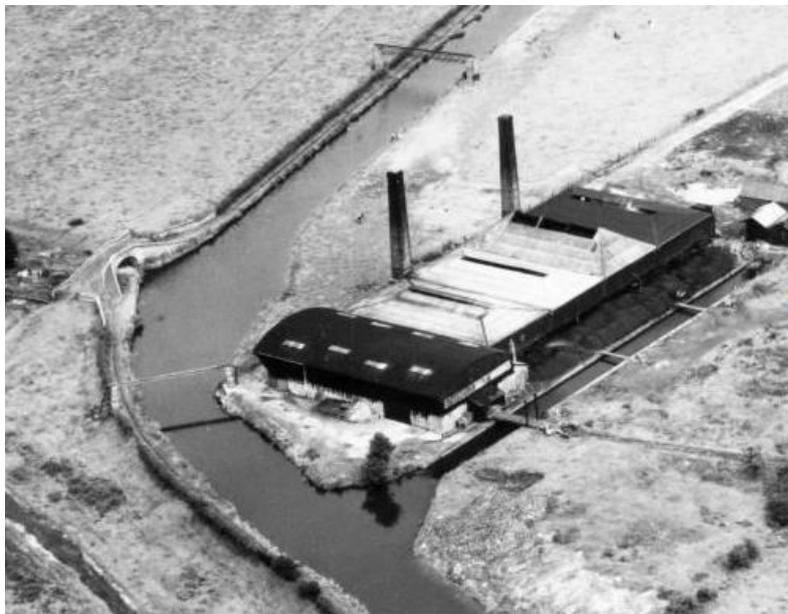
(j1) **Coming from Radford** along the Staffs & Worcs Canal, the Salt Works Canal Arm is on the right. The entrance seems wide enough to have allowed boats to successfully negotiate movements in or out of the Arm, although it was probably an easier manoeuvre going to or coming from Radford. The pipe over the Staffs & Worcs Canal carries brine to the Salt Works. The Roving Bridge and entrance to the former Stafford Branch Canal is on left. The water course at the lower left is part of the Deepmoor Drain. [Ref: From EAW0647]

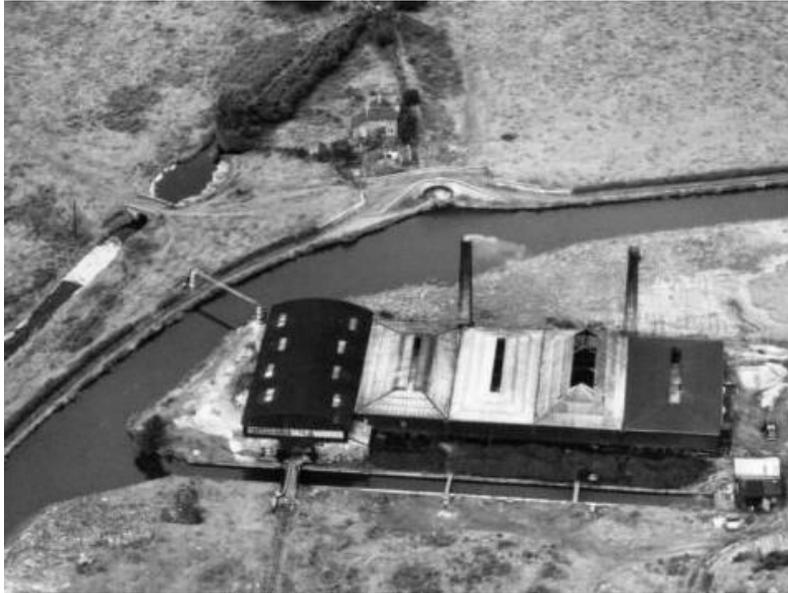
(j2) Salt Works and Canal Arm in the foreground. The pipe over the Staffs & Worcs Canal carries brine to the Salt Works. The Roving Bridge & Stafford Branch Canal are in the centre, and the small bridge over the Deepmoor Drain is to the left. There are no boats in the Arm. In 1939 L.T.C. Rolt reported in *Narrow Boat* the presence of a solitary Day Boat unloading its weekly cargo here. [Ref: from EAW0654]

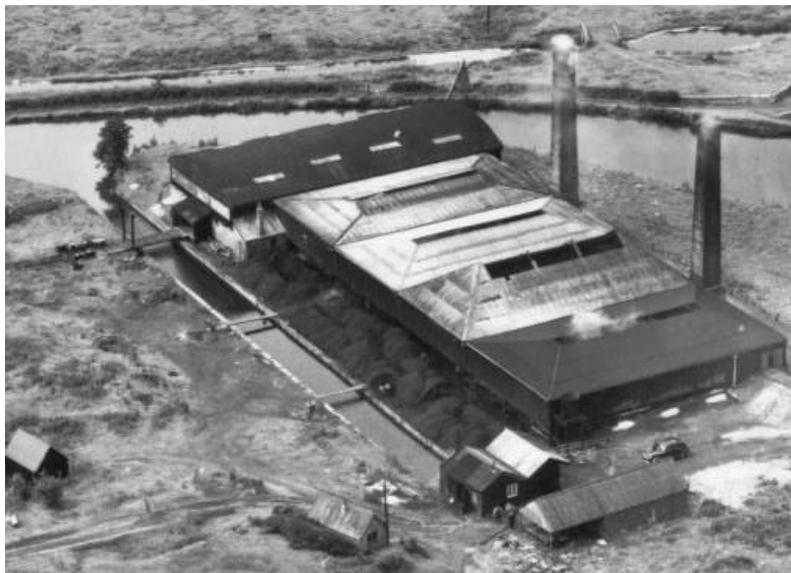
(j3) The Salt Works Canal Arm. The Arm is wide enough to accommodate two working narrowboats side by side. The brine pipe over the Staffs & Worcs Canal is just visible (upper centre), as is part of the Roving Bridge for the Stafford Branch Canal (upper far right). In this picture the small bridge over the Deepmoor Drain is to the right of the top of the more distant chimney. [Ref: From EAW0648]

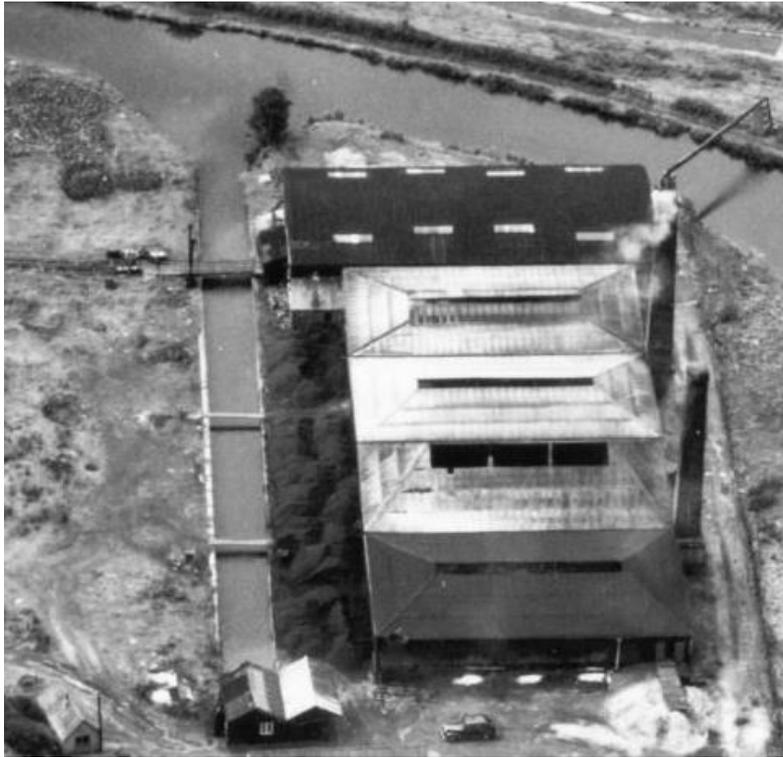
(j4) Good view of the Salt Works and Canal Arm; the brine pipe over the Staffs & Worcs Canal is in the upper right of the picture. There are no boats in the Arm. [Ref: From EAW0651]

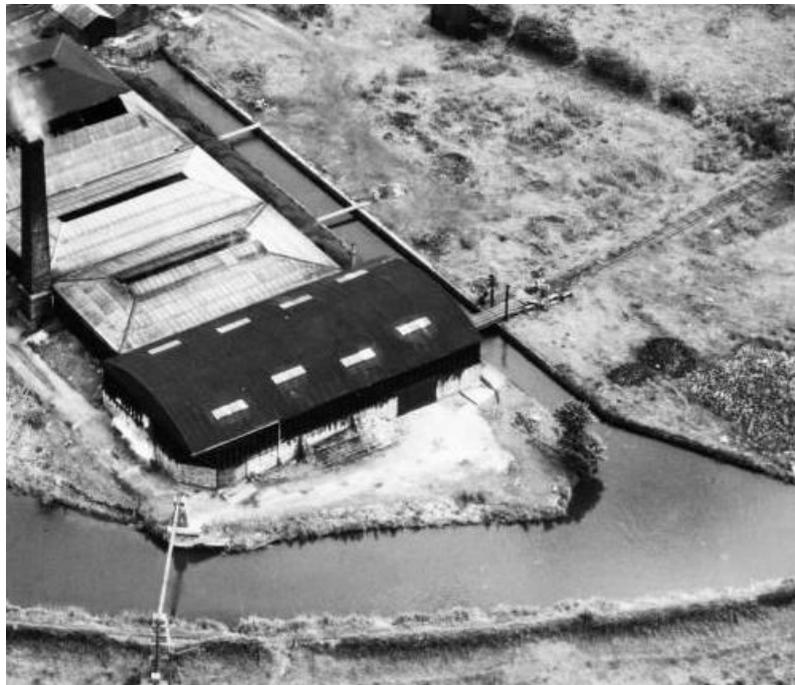
(j5) View of the Salt Works, Canal Arm and the brine pipe. Boats travelling from Milford along the Staffs & Worcs Canal (from left to right) would find it more difficult to enter the Salt Works Canal Arm than if travelling from Radford (right to left) because of the angle of approach. [Ref: From EAW0650]

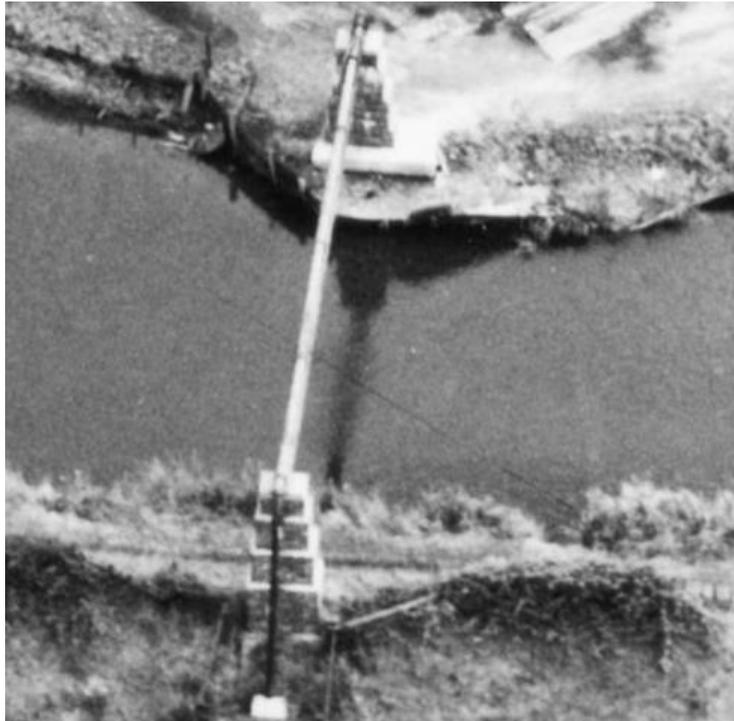
(j6) A close-up view of the brine pipe going over the Staffs & Worcs Canal and the towpath. [Ref: From EAW0650]

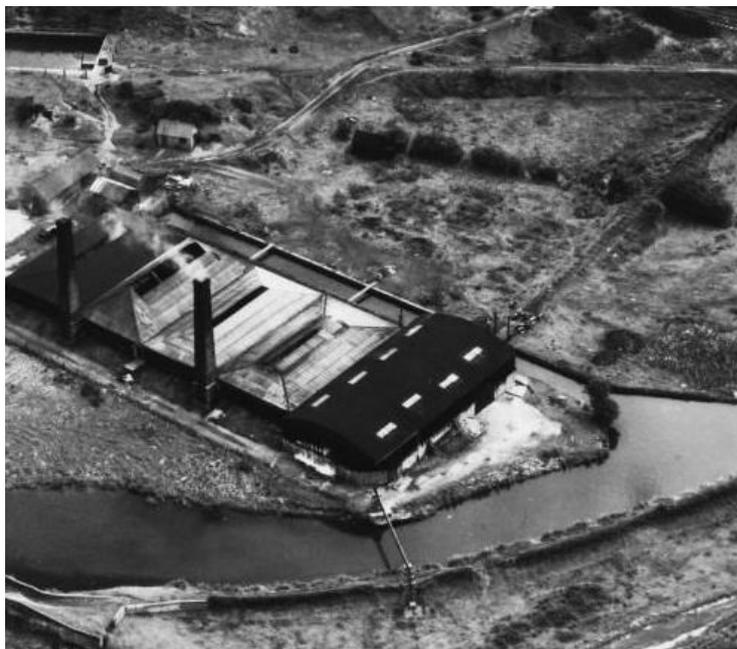
(j7) The Salt Works and Canal Arm; notice the pipe over the Staffs & Worcs Canal which carries brine to the Salt Works. The Roving Bridge to the Stafford Branch Canal at the lower left. [Ref: From EAW0649]
